Low-Slope Roofs Are Rotting: Case Study Resolution

By Dwight D. Benoy, PE;
Pamela Jergenson, CCS, CCCA, BECxP, CxA+BE;
and Gary C. Patrick, RRC, AIA

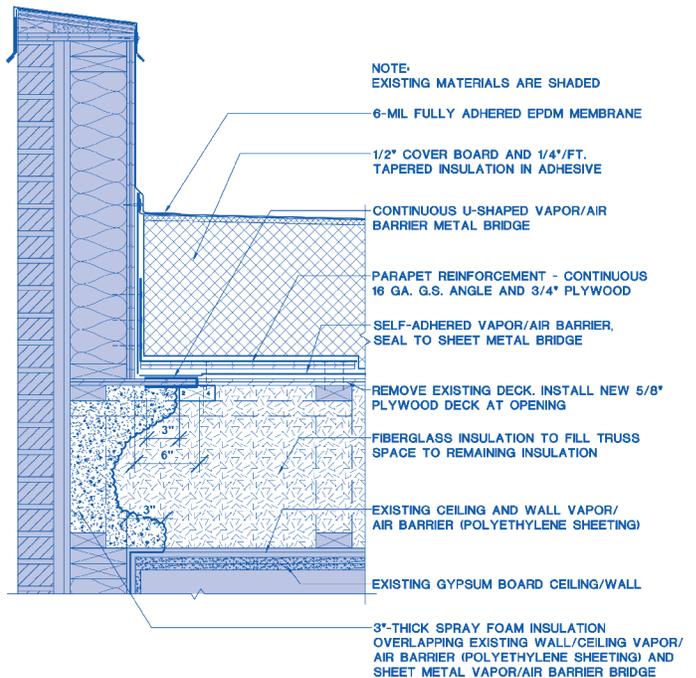
1 TALL PARAPET AT NON-BEARING ROOF TRUSS
A3 NO SCALE

Figure 3 – Detail from winning Option 2.

Option 2 is the solution that was ultimately selected and developed into construction documents for bidding and construction (Figure 3). This was the best solution to achieve the goal of a complete vapor/air barrier. It also exposed all the existing roof assembly to allow for the removal and remediation of wet, deteriorated, and moldy roof components. This option also maximized the reuse of the structural roof deck and blown-in insulation that was still in acceptable condition.

to reinforce the structure (Figure 3).

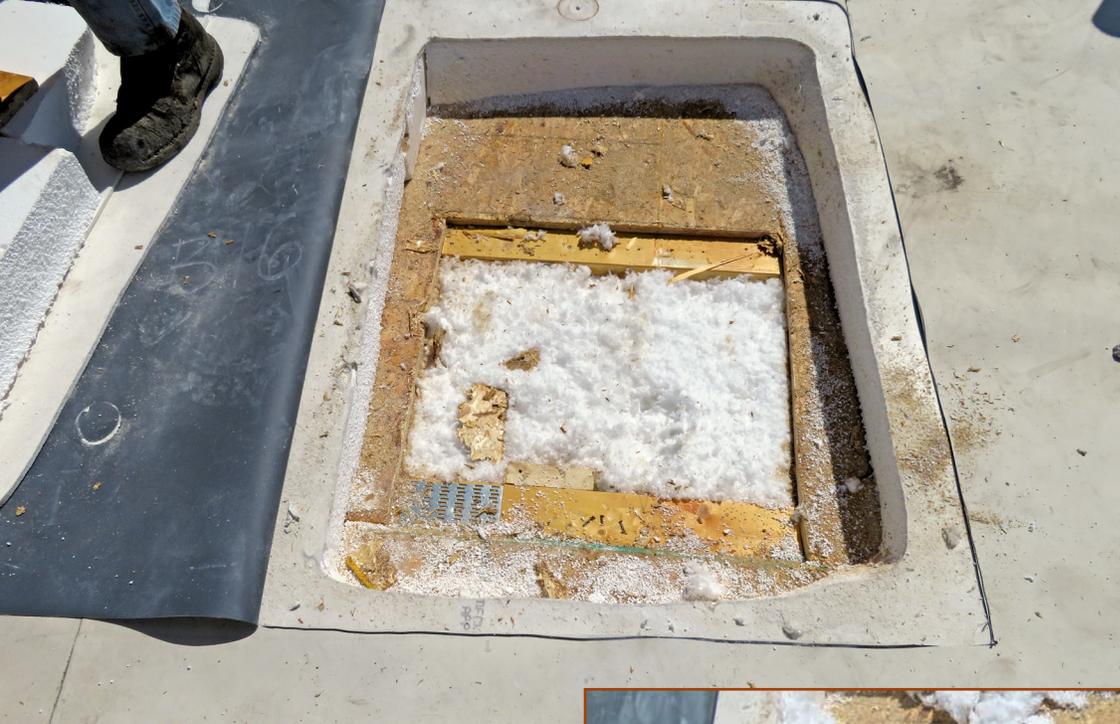
Figure 4 – Typical invasive inspection opening above trusses.

During the design phase, based on investigation-generated test results and observations, it was decided to make 60 invasive inspection openings prior to the start of construction to provide an idea of where the deck and insulation would need to be replaced (Figures 4 and 5). This would help the contractor better plan the construction work. The contractor awarded the reroofing project would make and repair the inspection openings.

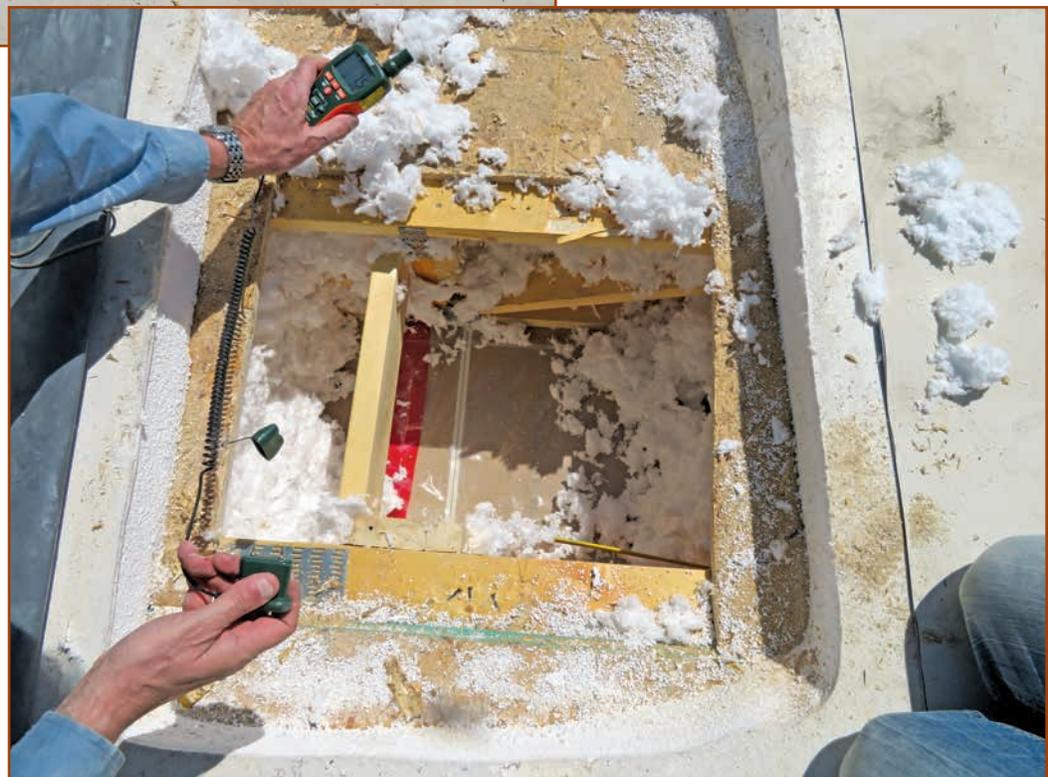
Figure 5 – Typical invasive inspection opening below roof deck sheathing.

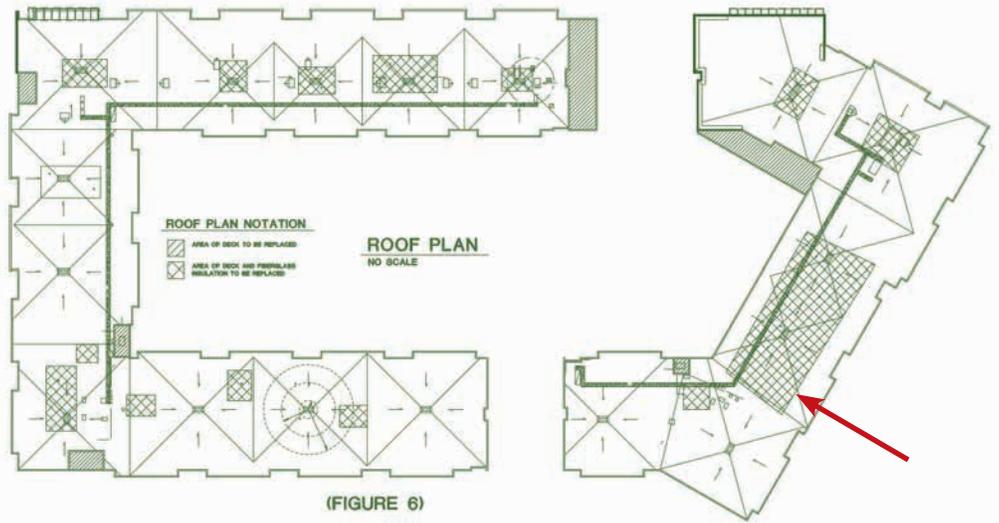
Based on the 60 invasive inspection openings, test results, and observations, a roof plan was developed showing the approximate areas where roof deck sheathing and blown-in insulation would most likely require replacement (Figure 6). The final determination of what needed replacement would be made by the contractor when each area was opened daily. While on site, performing their periodic observations, the A/E assisted the contractor to determine what needed to be replaced. A hand-held moisture meter was utilized daily, which worked well in determining the

Figure 6 – Approximate areas of roof deck and insulation replacement.

moisture content of the OSB structural roof deck. Industry convention indicates that a 16% moisture content would be the threshold for requiring replacement.

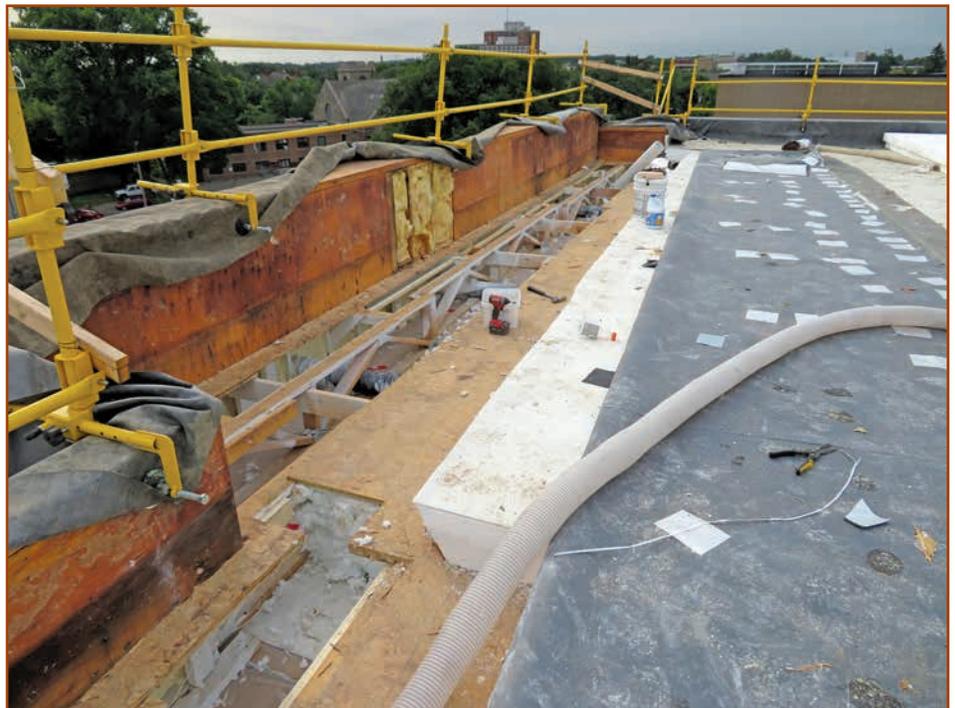
Figure 7 – Typical work at roof perimeter.

The contractor elected to do the perimeter work prior to the replacement work in the field of the roof (Figure 7). The perimeter work proved to be time-consuming and would have significantly reduced the size of the area that could be reroofed on a daily basis if it was done in conjunction with the field of the roof. The contractor could also schedule the perimeter work on days when

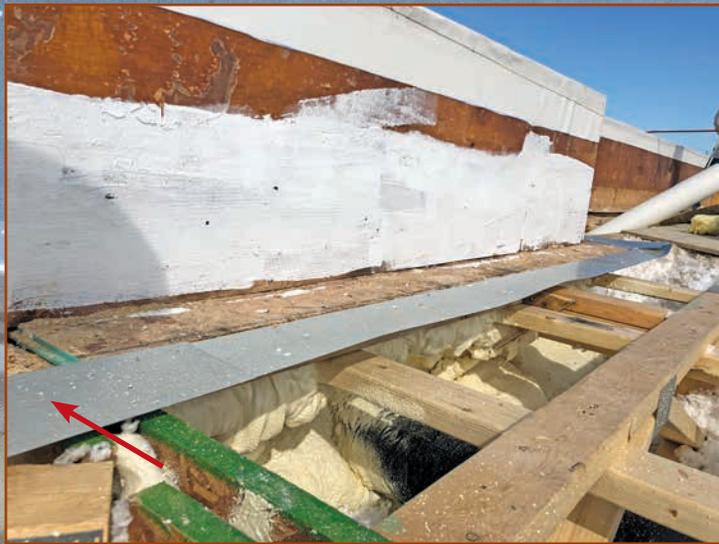
**Figure 8 –
Z-shaped
vapor/air
barrier
transition
metal.**

The contractor fabricated a Z-shaped transition metal instead of a U-shaped transition metal that served the same purpose as a vapor/air barrier transition material (Figure 8). However, there were areas of the previous mold remediation where additional framing done as part of that work interfered with the installation of the Z-shaped metal. Therefore, a two-piece U-shaped metal was installed with the connection between the pieces accomplished with aluminum tape (Figure 9).

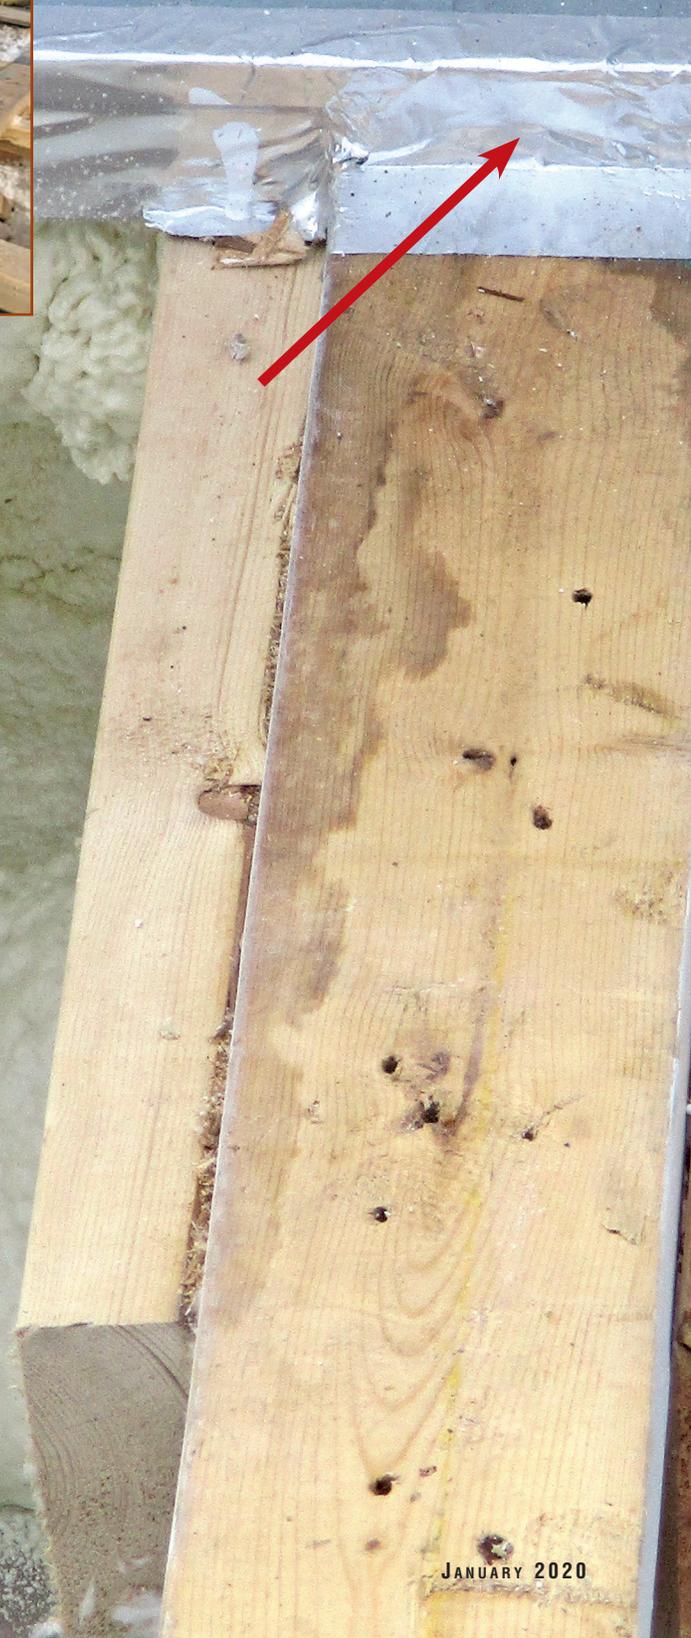
**Figure 9 – Two-piece U-shaped
vapor/air barrier transition metal.**

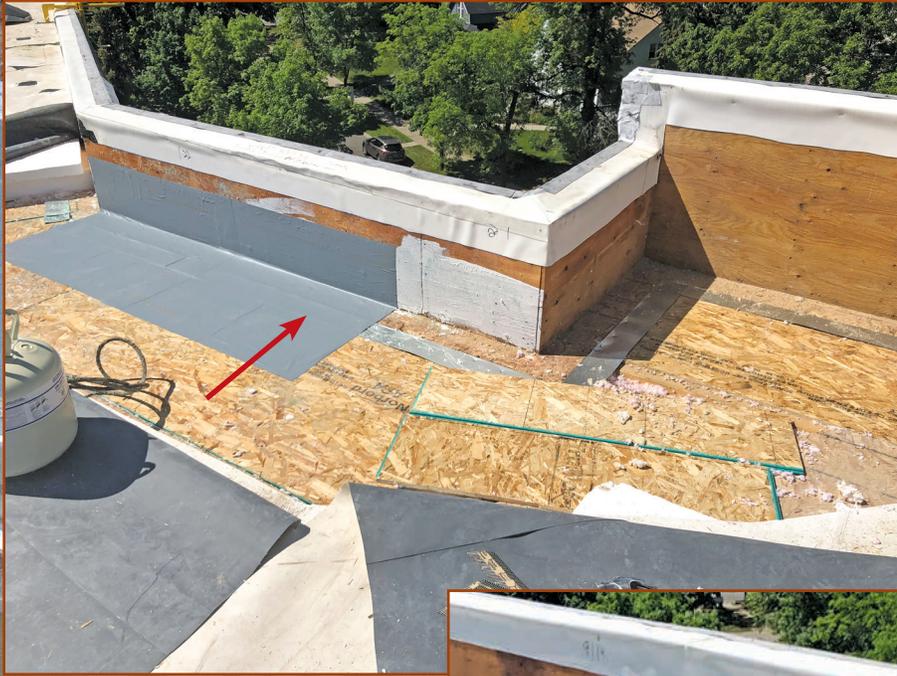
Figure 10 - Roof vapor/air barrier at roof perimeter.

After the Z-shaped transition flashing was installed, a short width of vapor/air barrier was installed (Figure 10), and then a parapet reinforcing assembly of plywood and sheet metal angle was installed (Figure 11), followed by the field of the roof vapor/air barrier (Figure 12).

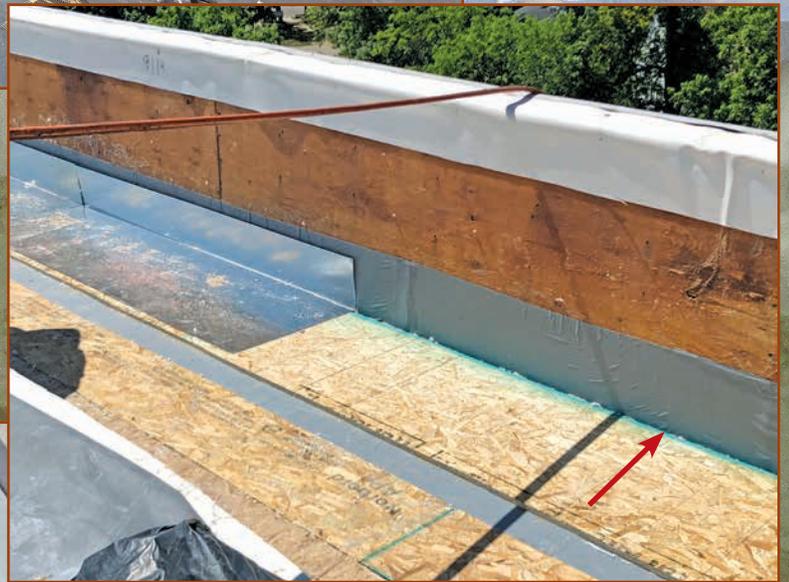
Figure 11 - Plywood and sheet metal angle parapet reinforcement.

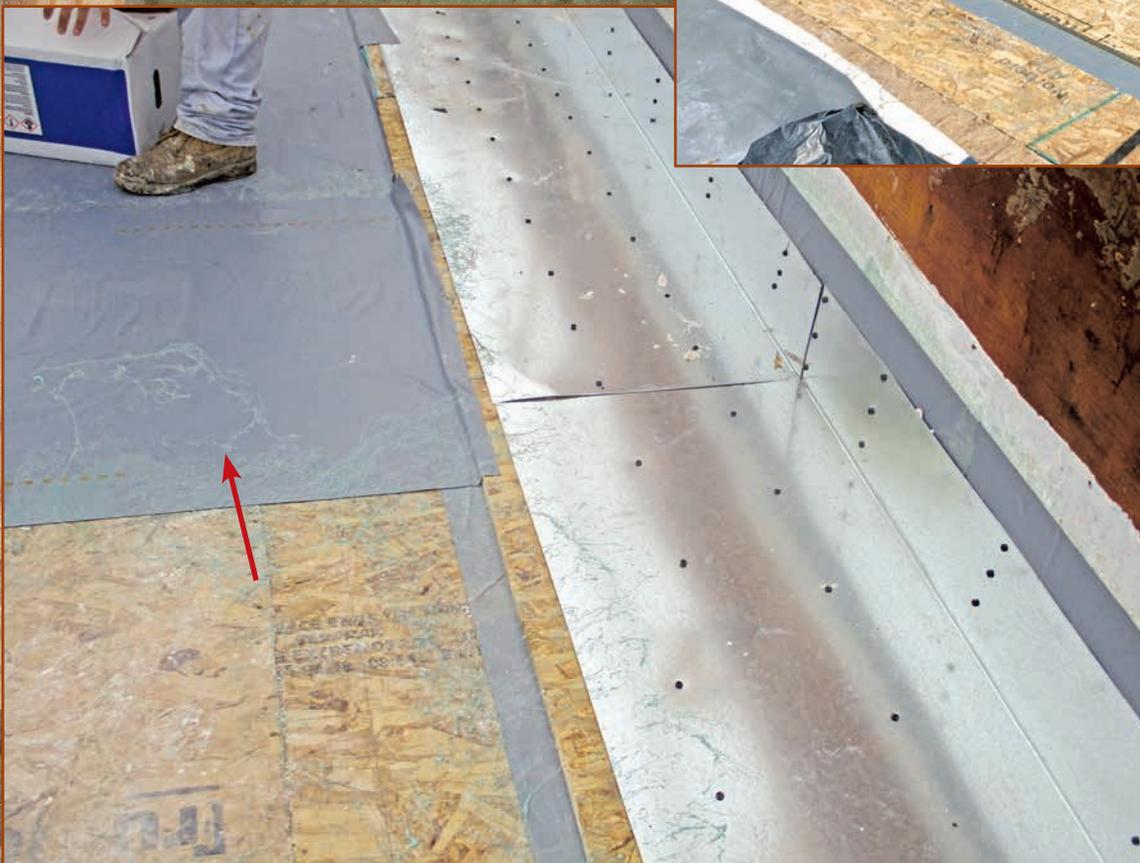
Figure 12 - Vapor/air barrier applied to field of roof.

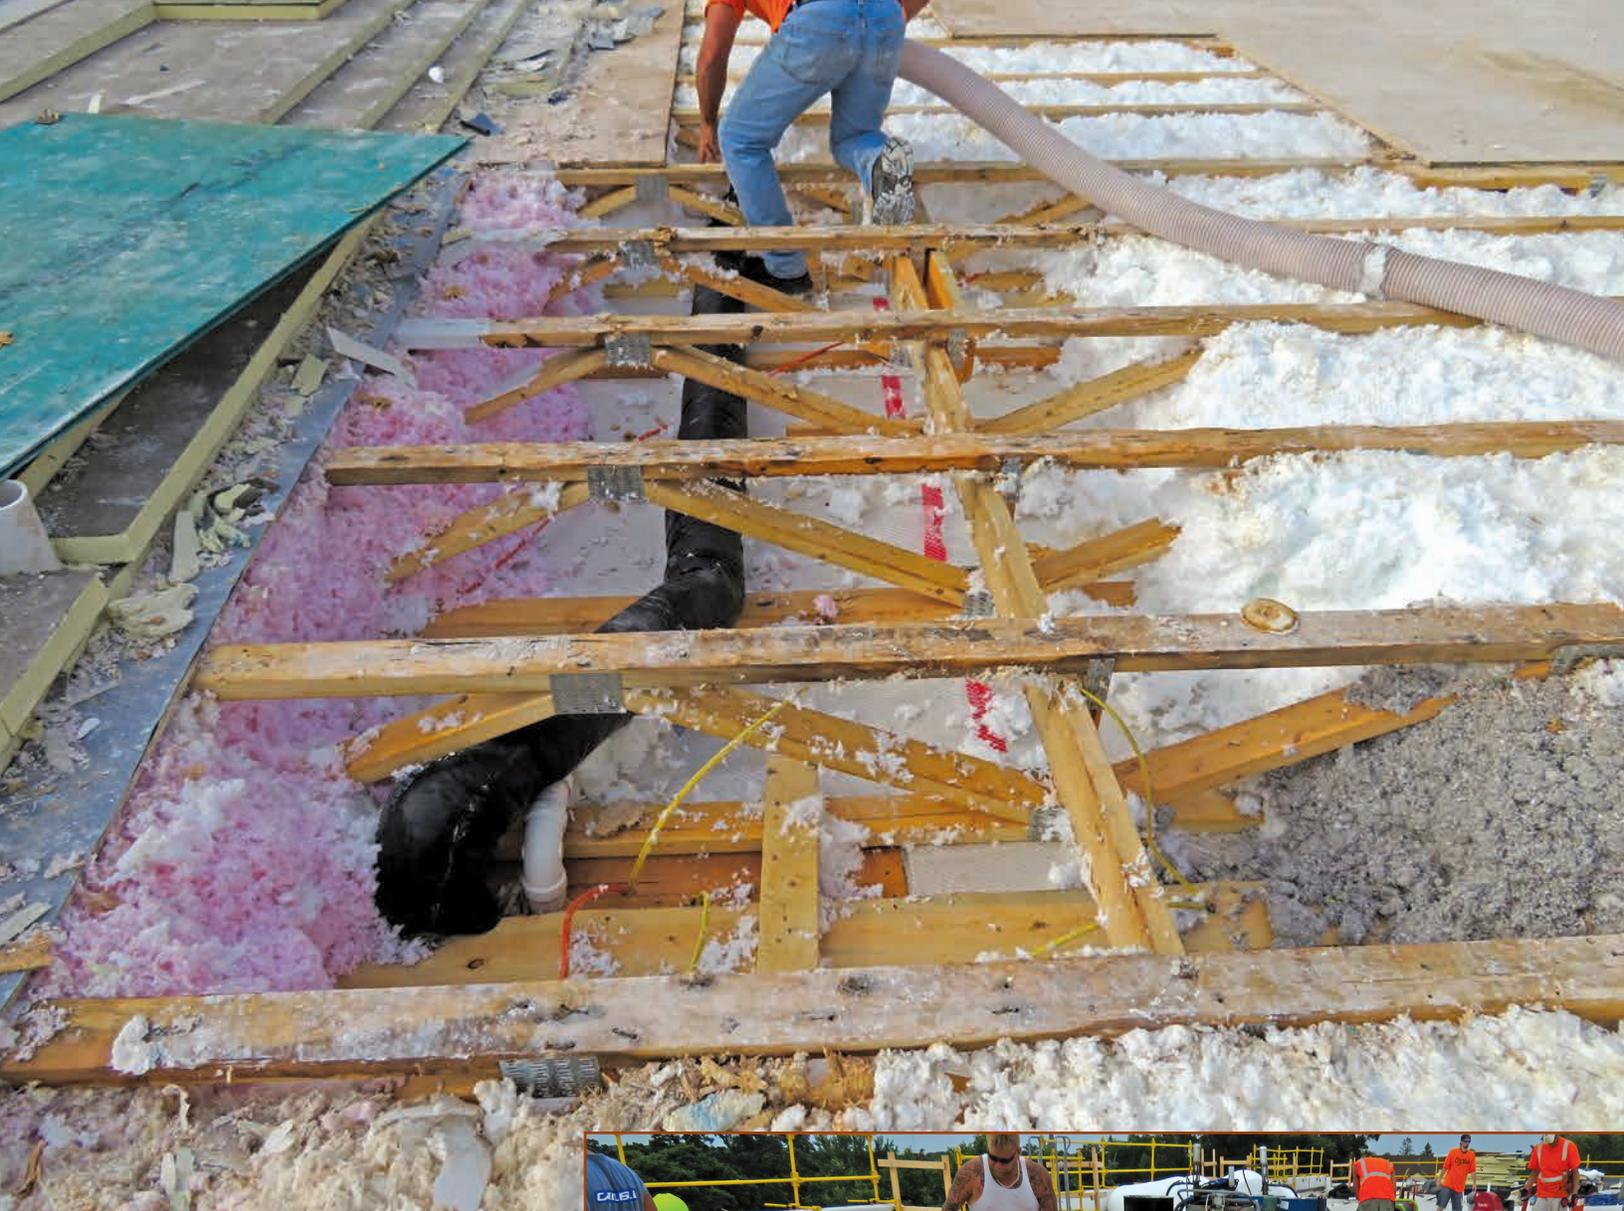
Figure 13 – Blown-in insulation.

Perimeter work required the insulation subcontractor to be on site to vacuum insulation, install the spray foam insulation in the rim area, and install new blown-in insulation on each day of perimeter work (Figure 13).

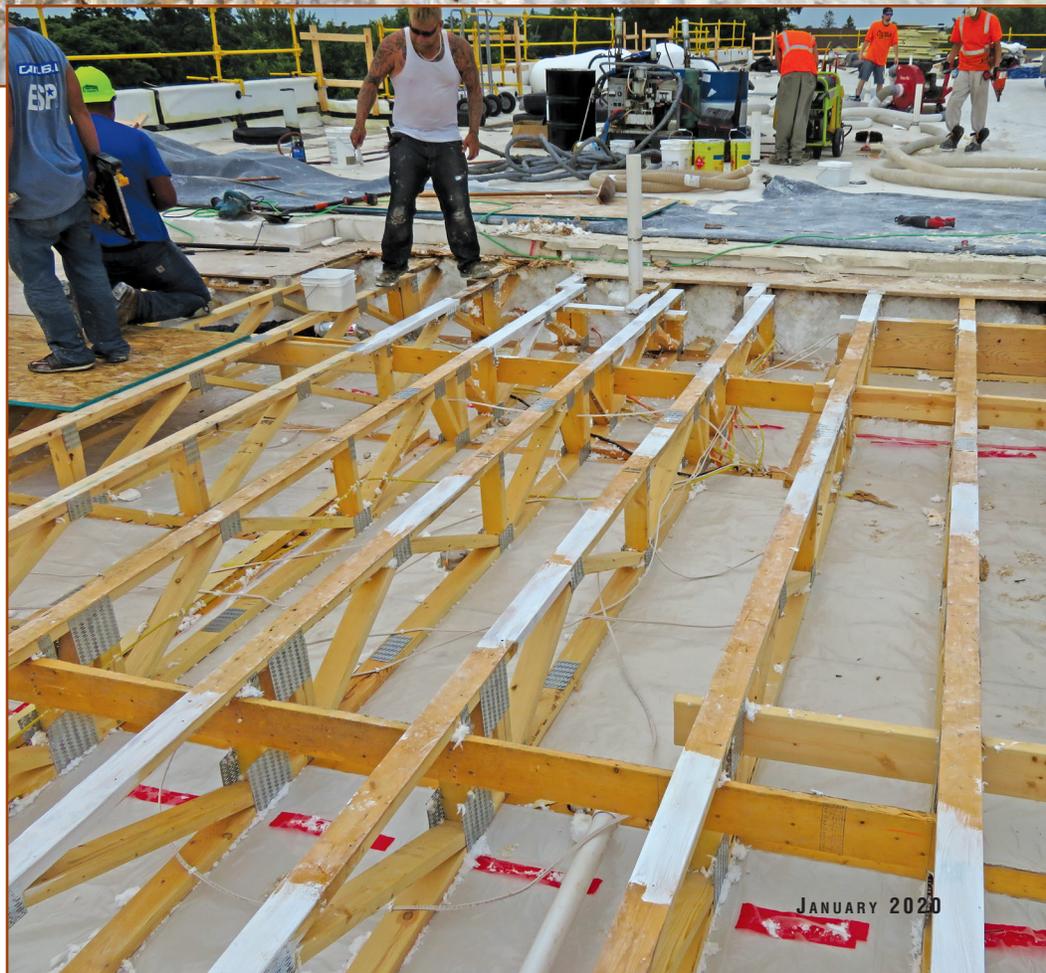
Figure 14 – Mold remediation paint.

Mold remediation was handled by the contractor, alleviating the need for a specialty contractor. This eliminated coordination and delay issues. The contractor cleaned any discolored areas that were within moisture content limits, then painted these areas with an antimicrobial paint (Figure 14). Most of the parapet that was left in place was remediated when the perimeter work was constructed, which proved to be the most efficient.
