# Low-slope Roofs are Rotting; Case Study Resolution

By Dwight D. Benoy, PE; Pamela Jergenson, CCS, CCCA, BECxP, CxA+BE; and Gary C. Patrick, AIA, RRC, CSI

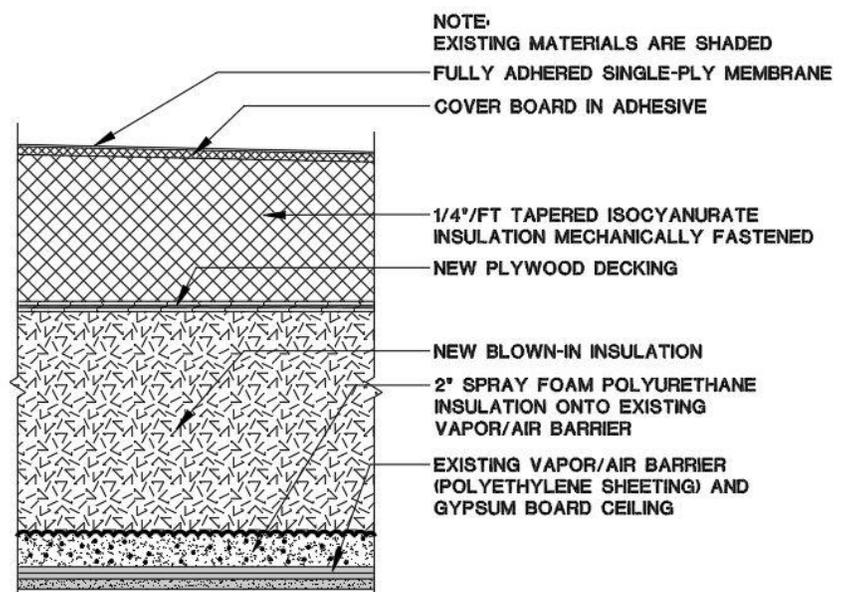
**OPTION 1 (FIGURE 1)**

This option was intended to create a complete vapor/air barrier by installing spray foam over the vapor/air barrier (polyethylene sheeting) and bottom chord of the truss. This required the removal of the existing roof system down to the structural roof deck and removal of a significant portion of the roof deck to facilitate vacuuming the existing blown-in insulation out of the truss space, and installation of the spray foam insulation and new blown-in insulation. New tapered insulation and roof membrane above the structural roof deck were part of this solution.

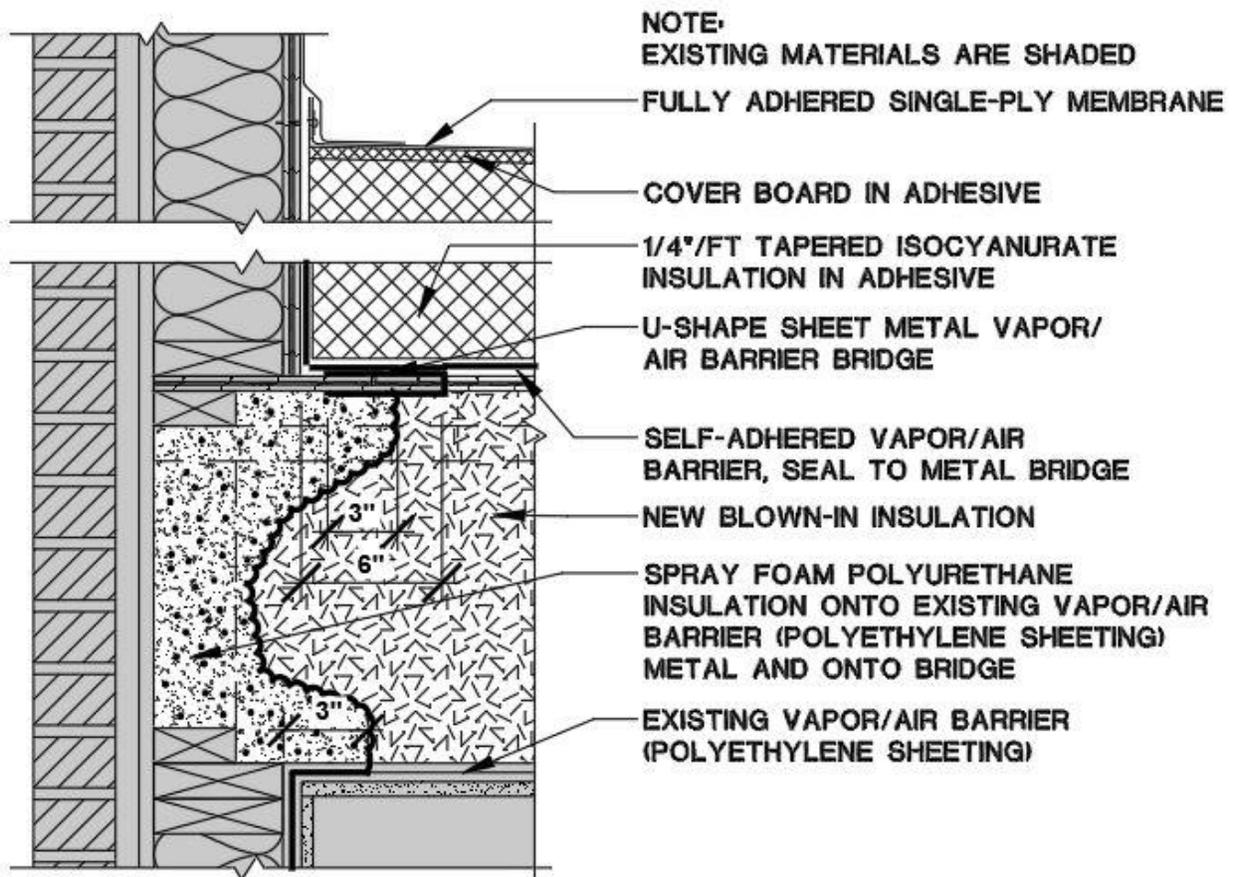
**OPTION 2 (FIGURE 2)**

Option 2 required removal of the existing roof system down to the structural roof deck, and replaced any wet, rotted and/or moldy deck and blown-in insulation. A roof vapor/air barrier would be applied on the structural roof deck.

Spray foam insulation of a minimum 3" thickness applied to the rim area was determined to be the most effective way in situ to transition the vapor/air barrier (polyethylene sheeting) from the exterior walls to the roof vapor/air barrier. The rim area is at the top of the exterior walls at the level of the 16"-deep roof trusses.

Sufficient insulation needed to be added above the structural roof deck to get the dew point temperature above the roof vapor/air barrier. This insulation also needed to be tapered to provide roof slope to the existing interior primary and overflow roof drains. The hygrothermal analysis showed a minimum of 4" of isocyanurate insulation was required to keep the dew point temperature above the roof vapor/air barrier. This meant all roof drains would need to be raised to accommodate the increased insulation thickness.

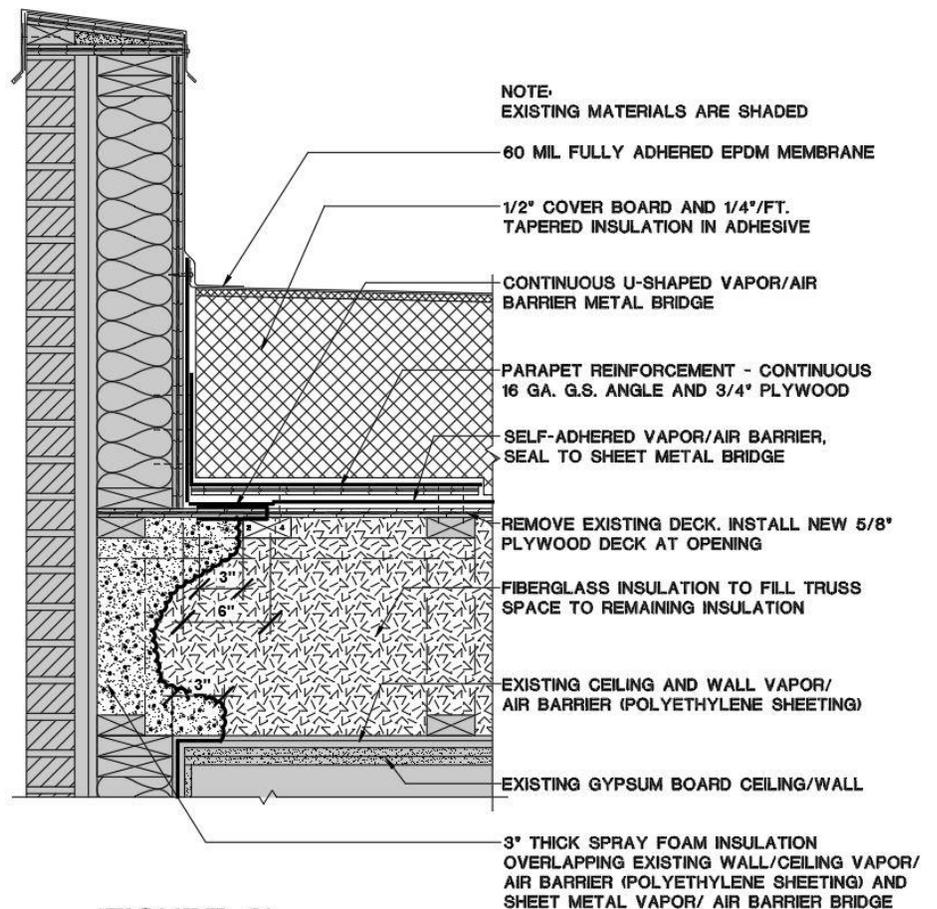
(FIGURE 3)

Option 2 is the solution that was ultimately selected and developed into construction documents for bidding and construction (Figure 3). This was the best solution to achieve the goal of a complete vapor/air barrier. It also exposed all the existing roof assembly to allow for the removal and remediation of wet, deteriorated, and moldy roof components. This option also maximized the reuse of the structural roof deck and blown-in insulation that was still in acceptable condition.

- The structural roof deck removal along the parapets compromised the structural integrity of the roof perimeter at some conditions, so an engineered solution was required that included continuous steel angles and plywood sheathing be added to reinforce the structure (Figure 3).

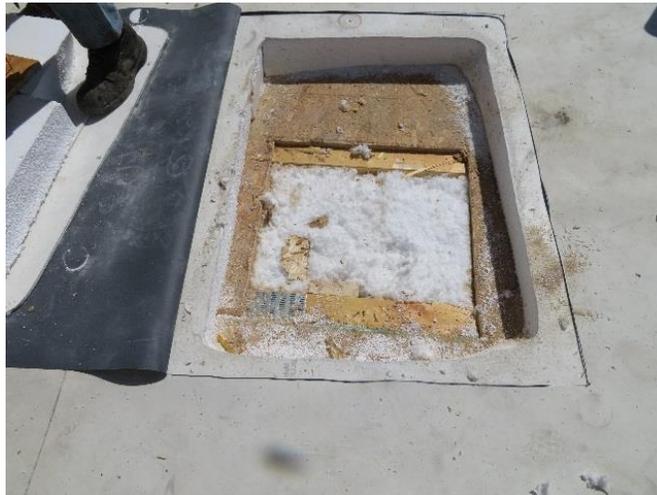
Figure 4

During the design phase, based on investigation-generated test results and observations, it was decided to make 60 invasive inspection openings prior to the start of construction to provide an idea of where the deck and insulation would need to be replaced (Figures 4 and 5). This would help the contractor better plan the construction work. The contractor awarded the reroofing project would make and repair the inspection openings.

Typical invasive inspection opening above trusses.

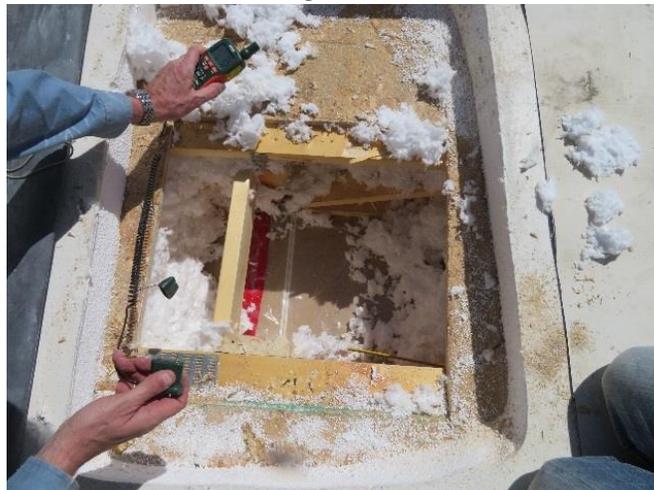
Figure 5

Typical invasive inspection opening below roof deck sheathing.

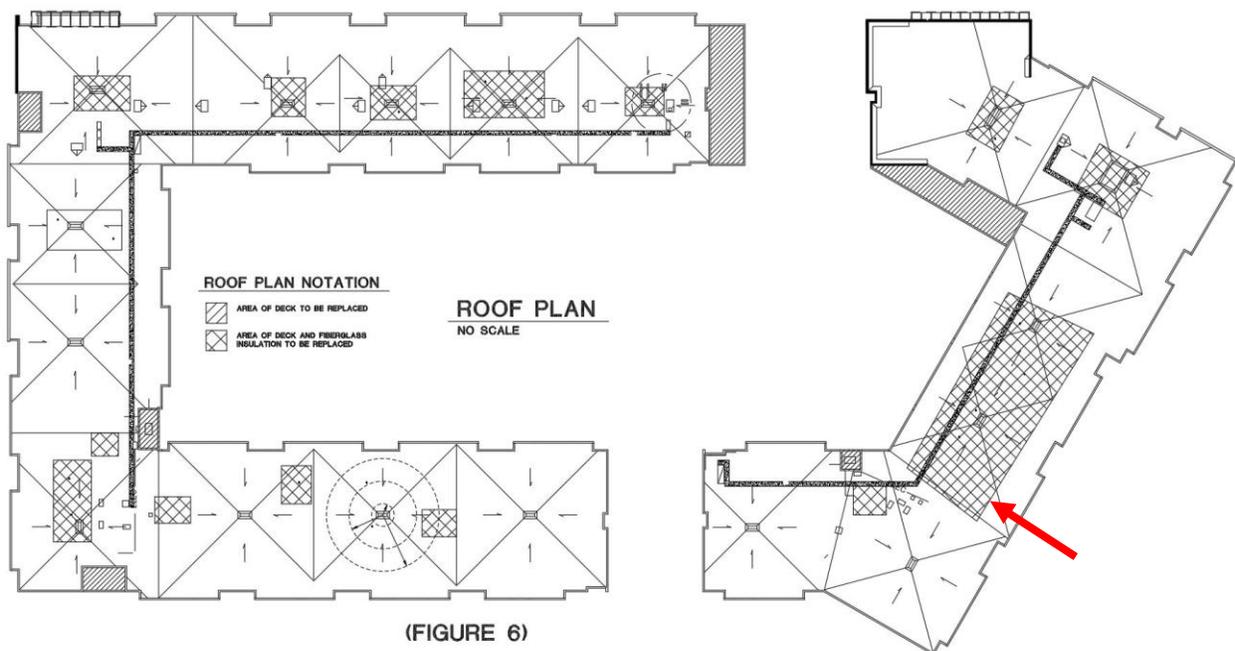
Based on the 60 invasive inspection openings, test results and observations, a roof plan was developed showing the approximate areas where roof deck sheathing and blown-in insulation would most likely require replacement (Figure 6). The final determination of what needed replacement would be made by the contractor when each area was opened daily. While onsite performing their periodic observations, the A/E assisted the Contractor to determine what needed to be replaced. A hand-held Delmhorst moisture meter was utilized daily, which worked well in determining the moisture content of the OSB structural roof deck. Industry convention indicates that a 16% moisture content would be the threshold for requiring replacement.

Approximate Areas of roof deck and insulation replacement

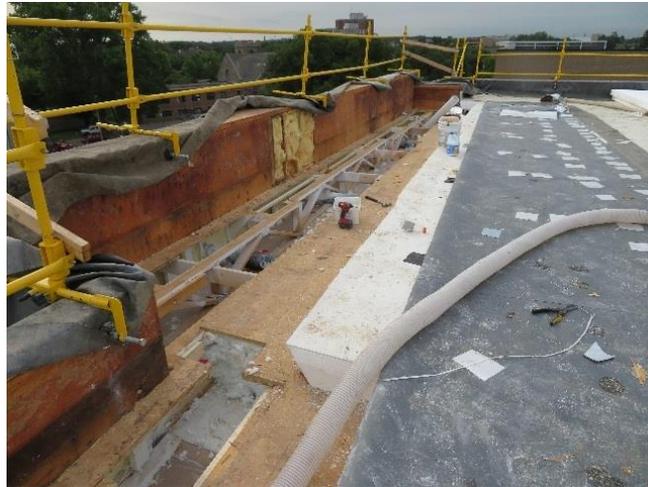
Figure 7

The Contractor elected to do the perimeter work prior to the replacement work in the field of the roof (Figure 7). The perimeter work proved to be time-consuming and would have significantly reduced the size of the area that could be reroofed on a daily basis if it was done in conjunction with the field of the roof. The contractor could also schedule the perimeter work on days when the weather forecast was a bit questionable as the perimeter could be enclosed rapidly should precipitation be imminent.

Typical work at roof perimeter.

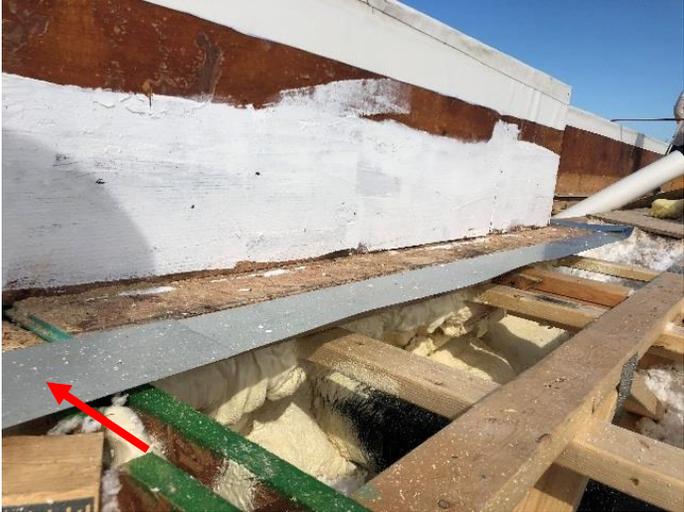
Figure 8

The Contractor fabricated a Z-shaped transition metal instead of a U-shape transition metal that served the same purpose as a vapor/air barrier transition material (Figure 8). However, there were areas of the previous mold remediation where additional framing done as part of that work interfered with the installation of the Z-shaped metal. Therefore, a two-piece U-shaped metal was installed with the connection between the pieces accomplished with aluminum tape (Figure 9).

Z-shaped vapor/air barrier transition metal.

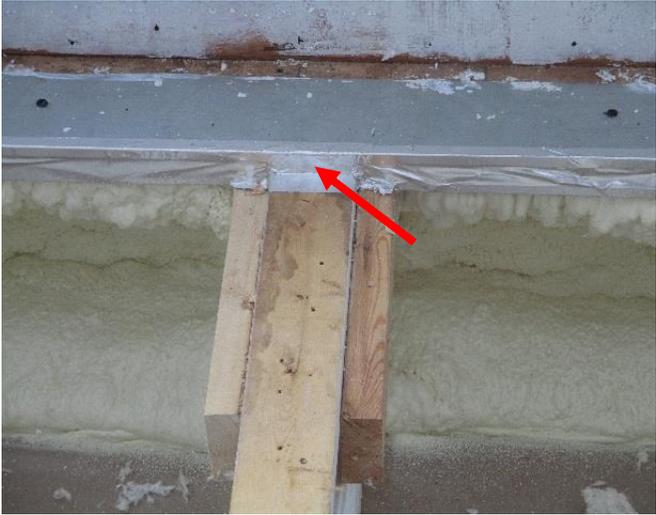
Figure 9

Two-piece U-shaped vapor/air barrier transition metal.

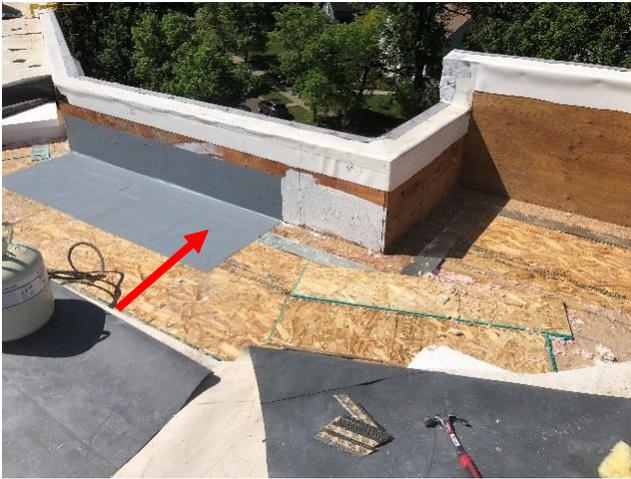
Figure 10

After the Z-shaped transition flashing was installed, a short width of vapor/air barrier was installed (Figure 10), and then a parapet reinforcing assembly of plywood and sheet metal angle was installed (Figure 11) followed by the field of the roof vapor/air barrier (Figure 12).

Roof vapor/air barrier at roof perimeter.

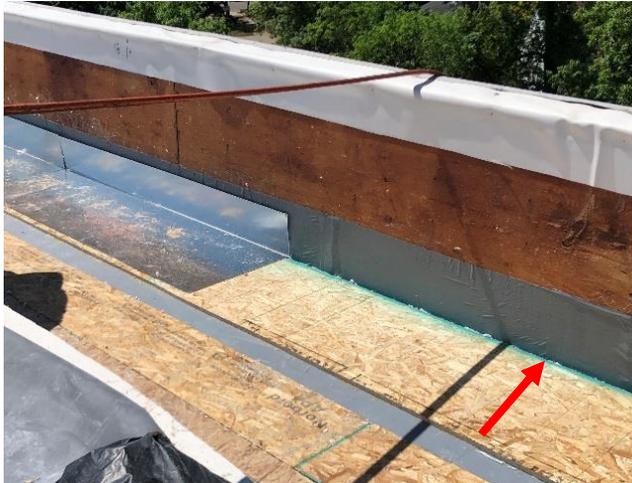
Figure 11

Plywood and sheet metal angle parapet reinforcement.

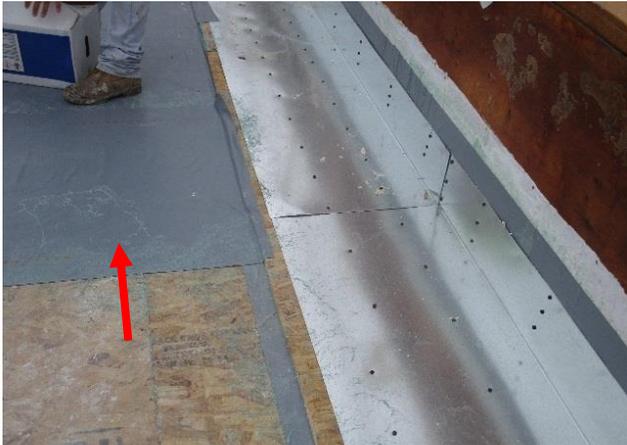
Figure 12

Vapor/air barrier applied to field of roof.

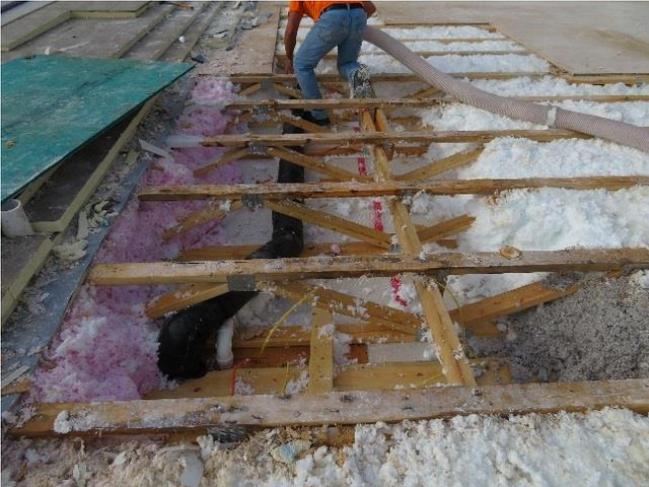
Figure 13

The Contractor had on-call local insulation and plumbing subcontractors under contract and available to complete varying amounts of work, depending on what was uncovered and anticipated each day. Perimeter work required the insulation subcontractor to be on site to vacuum insulation, install the spray foam insulation in the rim area, and install new blown-in insulation on each day of perimeter work (Figure 13).

Blown-in insulation.

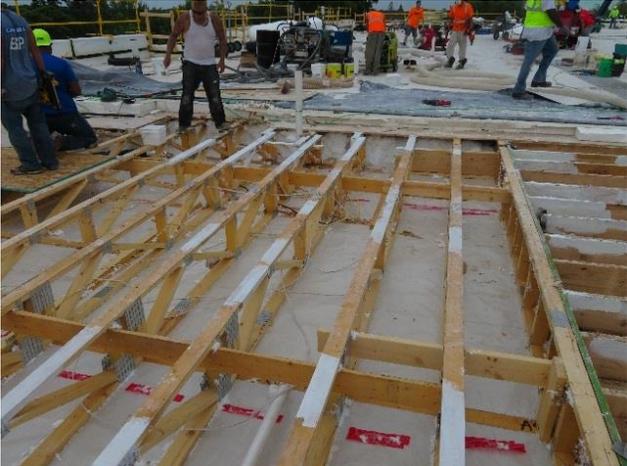
Figure 14

Mold remediation was handled by the Contractor, alleviating the need for a specialty contractor. This eliminated coordination and delay issues. The Contractor cleaned any discolored areas that were within moisture content limits, then painted these areas with an anti-microbial paint (Figure 14). Most of the parapet that was left in place was remediated when the perimeter work was constructed, which proved to be the most efficient.

Mold remediation paint.

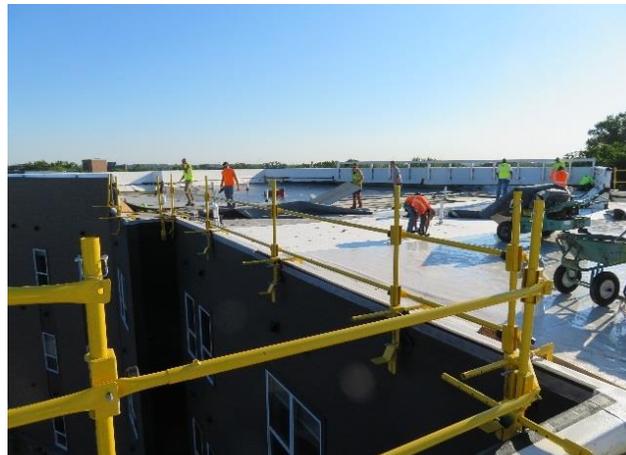
Figure 15

Perimeter safety was primarily accomplished with rails attached to the parapet (Figure 15). A safety monitor was also assigned to work with the crew applying the low-rise foam adhesive for the insulation attachment.

Perimeter safety rails.

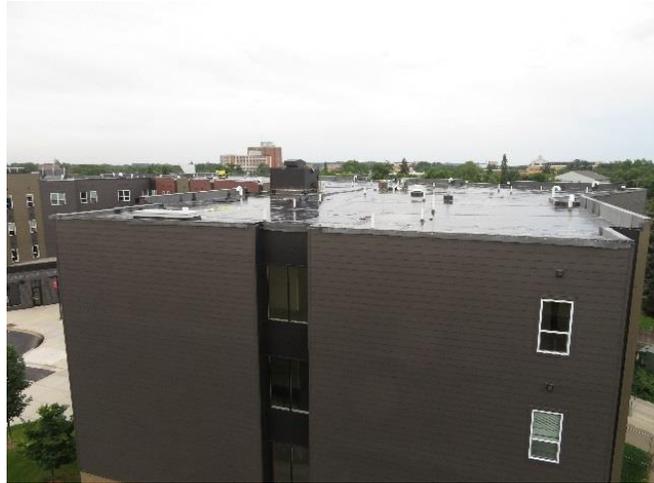
Figure 16

The fully adhered EPDM membrane over the tapered insulation system provided a fully draining roof with a finished appearance (Figure 16). Even with all of the construction challenges, the roof was completed in a timely manner.

Completed roof.
