Improper Use of Storefront Window Systems Leading to Costly Repairs:

A CASE STUDY

By Jason Popovich

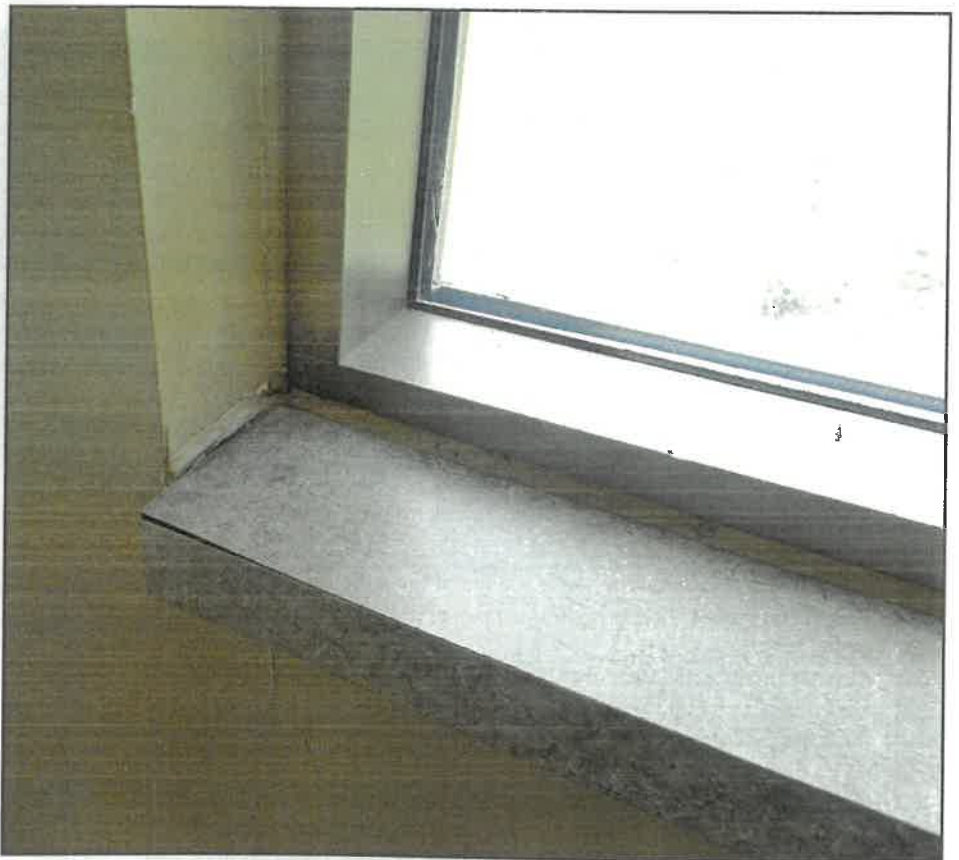
In early 2021, members of a church in Minneapolis, Minnesota, were frustrated after experiencing years of issues dealing with water infiltration below the church windows, which had caused the plastic-laminate sills to visibly swell as they took on water (Fig. 1).

Figure 1. Visible moisture damage of the plastic laminate sills. Photo courtesy of Inspec.

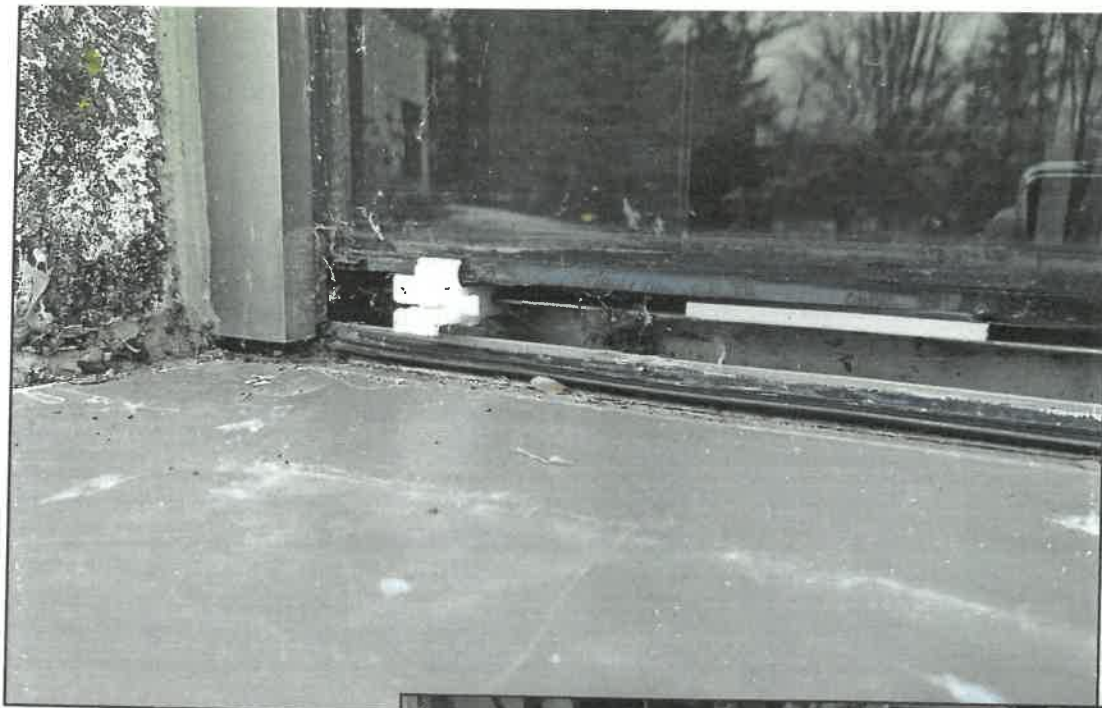
Figure 2. Plastic clips secured the aluminum to the glazing gaskets, allowing movement and water entry. Photo courtesy of Inspec.

pressures on a building will cause the glass panes to push away from the glazing gaskets, allowing water to penetrate the system. The plastic clips of the church's storefront system (Fig. 2) secured the exterior aluminum with the glazing gaskets, allowing the aluminum to move. This movement caused gaps in the gasketing, allowing water to enter the mullion system. This water then needed to be managed.

This combination of factors led the consultant to recommend replacing the existing larger openings with a curtainwall system, which would incorporate a pressure bar with gasketing that is fastened to the mullions to resist the movement that allows water in. There were two options for the windows located at the

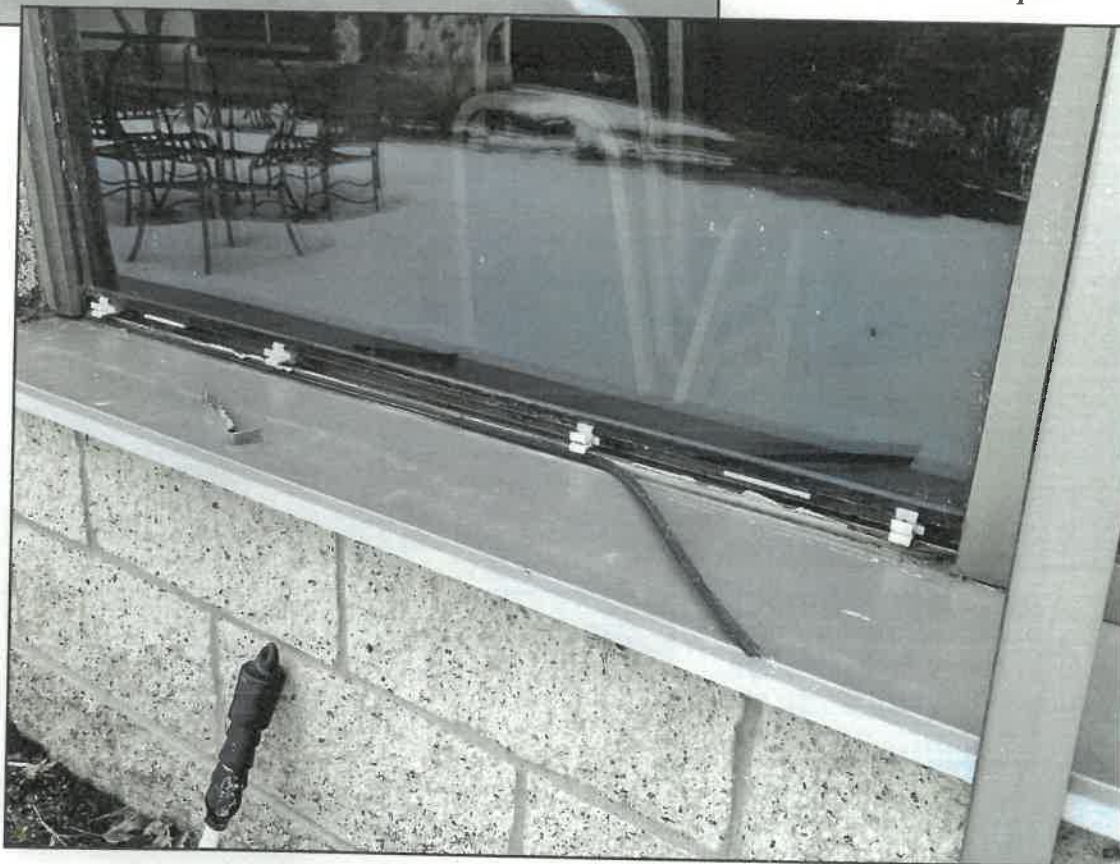
Figure 3. The window frames did not incorporate a sill pan to direct water to the exterior. The flashing shown stopped at the front of the window, where it met the gasketing and no end dams were incorporated. Note the previous attempt to seal the window system from the outside where the flashing met the gasketing. Photo courtesy of Inspec.

Upon removing the trim, the consultant determined that there was no sill pan beneath the frame to direct intruded water that would run down the vertical channels back to the exterior (Fig. 3). The flashing over the sloped block on the exterior terminated at the front of the sill where the gasketing is located. Without a sill pan and end dams, water within the system was able to enter the interior space below the sill. The previous attempts to seal the window system from the outside further prevented moisture within the system from escaping.

The consultant determined that the lack of a proper collection and drainage system was the cause of the initial water infiltration. The addition of sealant to the exterior further inhibited the drainage of water. These combined factors resulted in an abundance of water that collected below the sill, leading to the damage to the sills and the framing beneath.

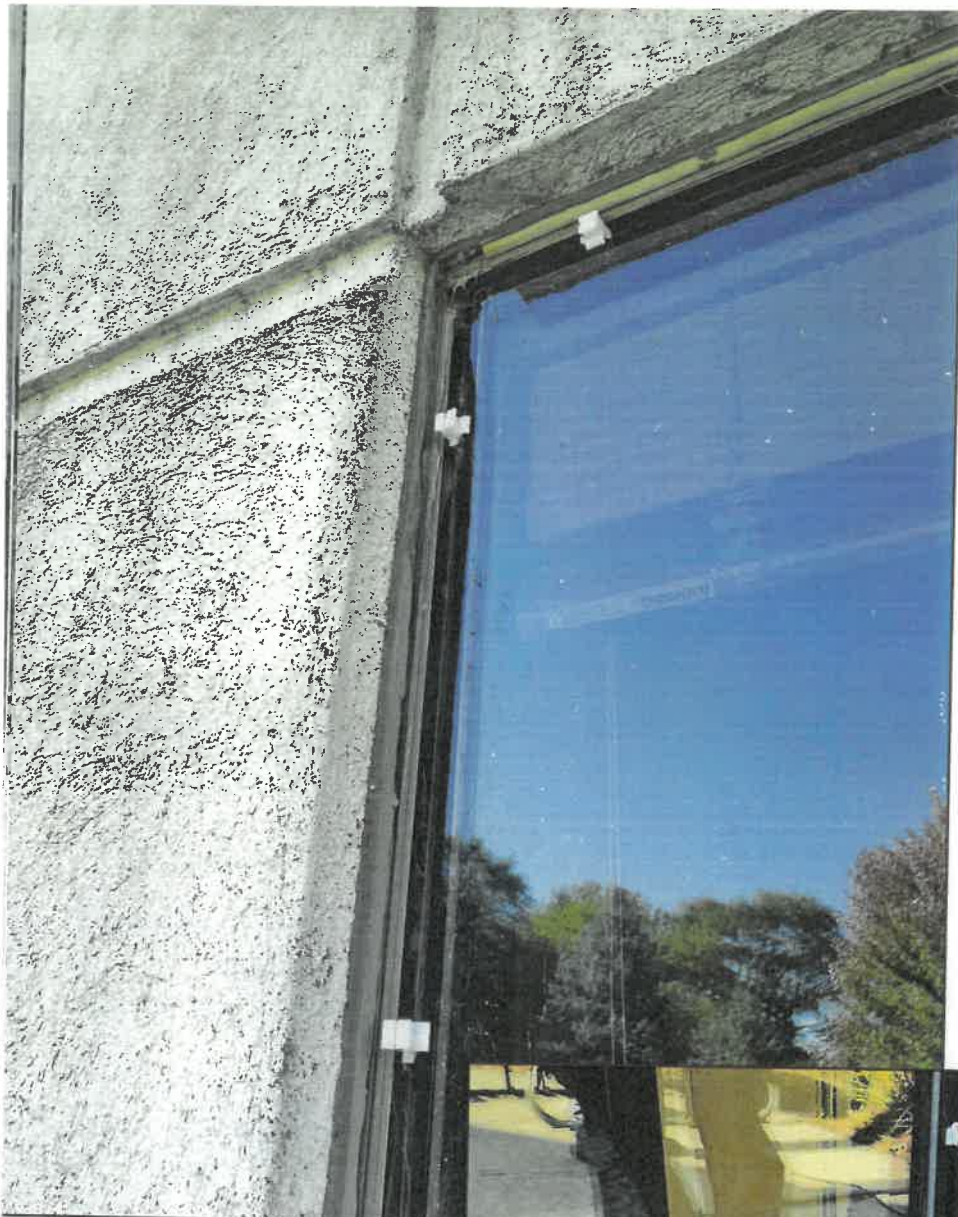
Figure 4. There was no evidence of existing weep holes, which would have provided drainage of water to the exterior. Photo courtesy of Inspec.

Even if water is directed to the exterior, it still needs a means to escape. Therefore, proper weeps must be incorporated. In their further review of the church windows, the consultant also found a lack of existing weep holes (Fig. 4).

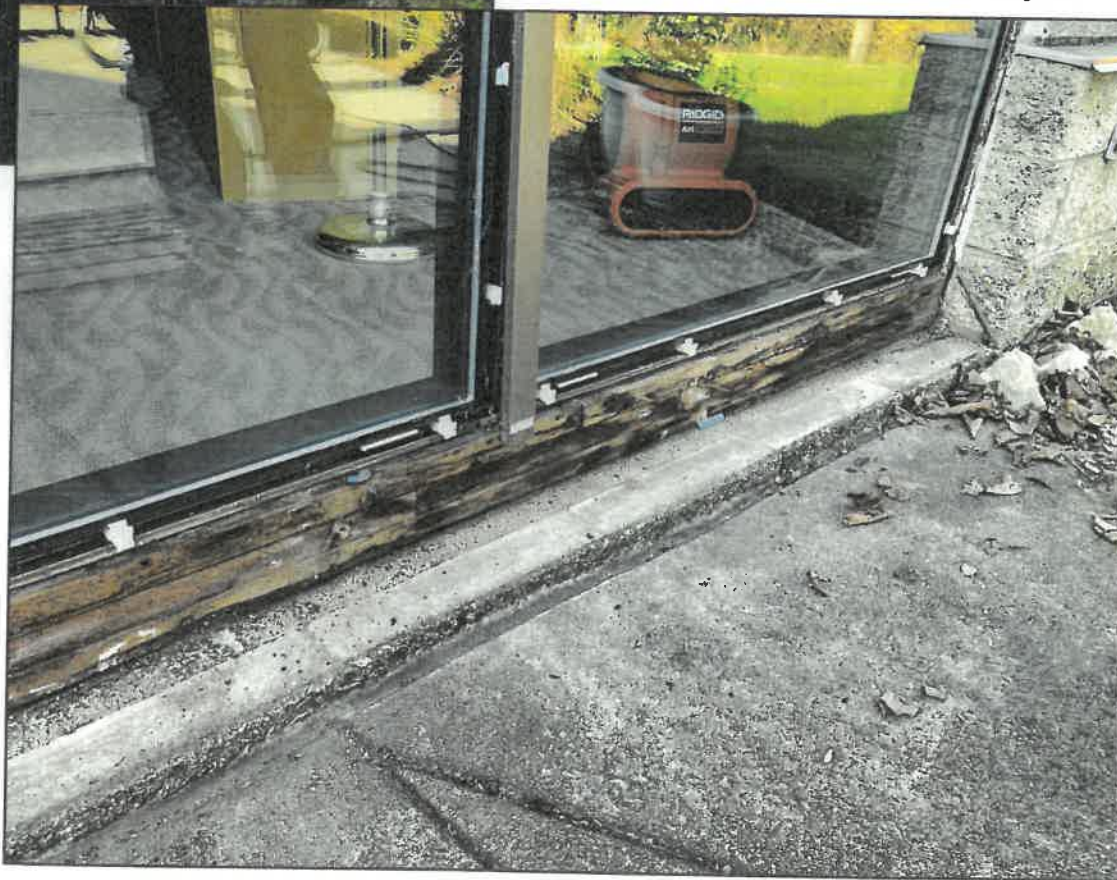
Figure 5. Because the storefront window system lacked proper sill pans and end dams, water could escape into the wall below the sill, causing damage to stacked wood framing. Photo courtesy of Inspec.

they were susceptible to additional moisture from surface runoff. The lack of any protective membrane or other means of waterproofing resulted in even more extensive damage to the stacked wood frames, as is evident in Fig. 5.
