REPAIR OF ABOVE-ROOFLINE PARAPET WALLS ON VINTAGE STRUCTURES

By Don Kilpatrick and Michael Wiscons, SE, PE

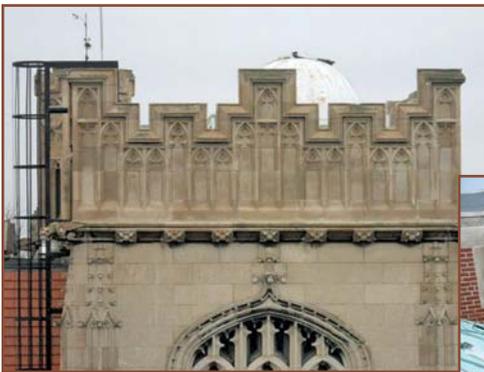
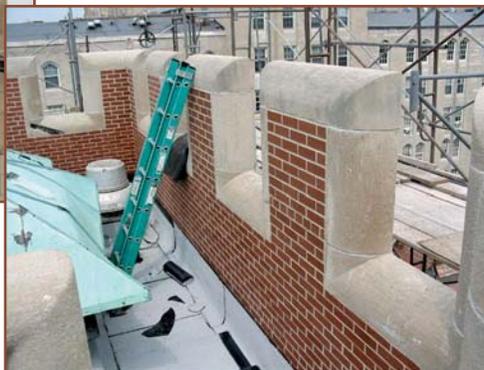
Photos 1A and 1B – Examples of a "crenellated" parapet wall or battlement as identified by the alternating high (merlon) and low (crenel) points of the feature.

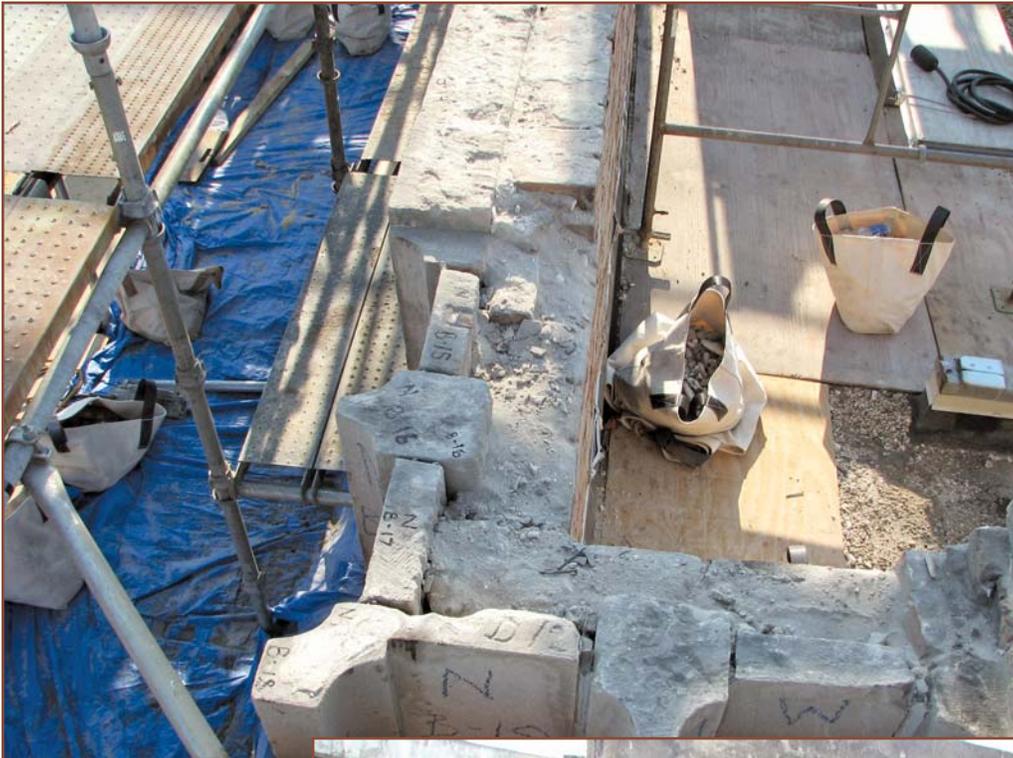
Photo 2 – Cut/carved stones labeled for correct spotting during reconstruction.

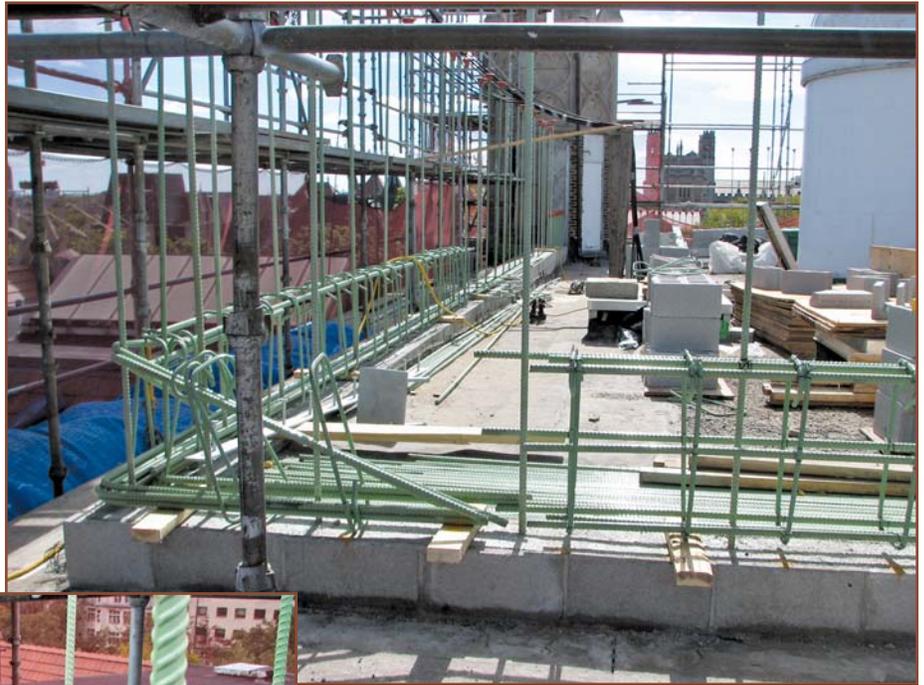
Photo 4 – Rebar set for forming and pouring of a new concrete beam above existing roofline.

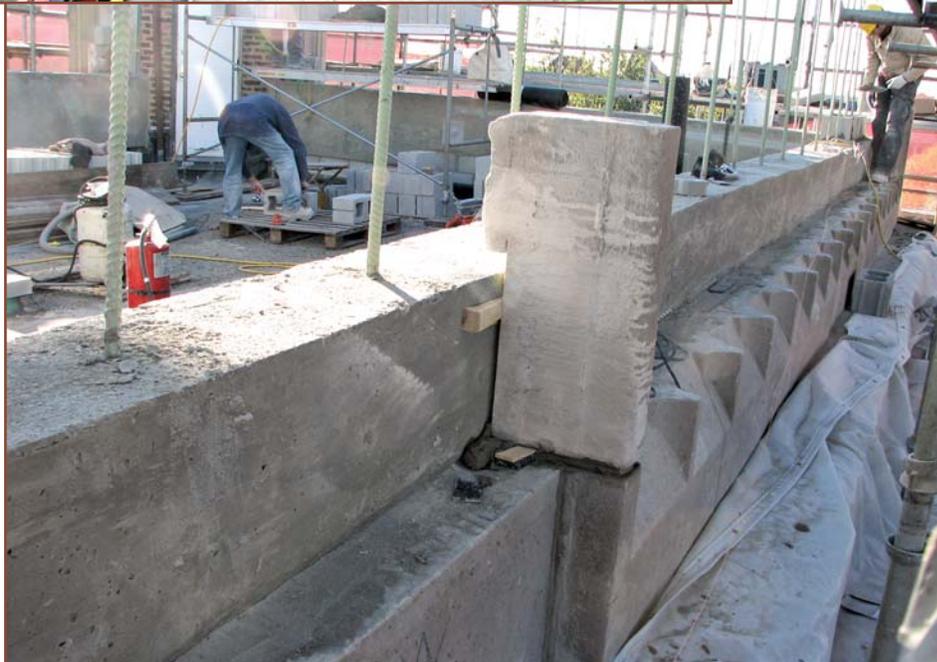
Photo 6 – Stone requiring field cut to accommodate new tolerances established by the concrete beam.

On projects in which the scope includes the complete reconstruction of the brick masonry backup wall—utilizing a steel-reinforced, fully grouted CMU wall section—the 8-in. bond stones may need to be field cut to 4-in. thickness so as not to interfere with the continuity of a bond beam and/or reinforcing steel set in the fully grouted cells of the new backup. Any new steel (generally limited to anchors for resetting of the stone, in the form of pins and clips) should be of stainless steel.

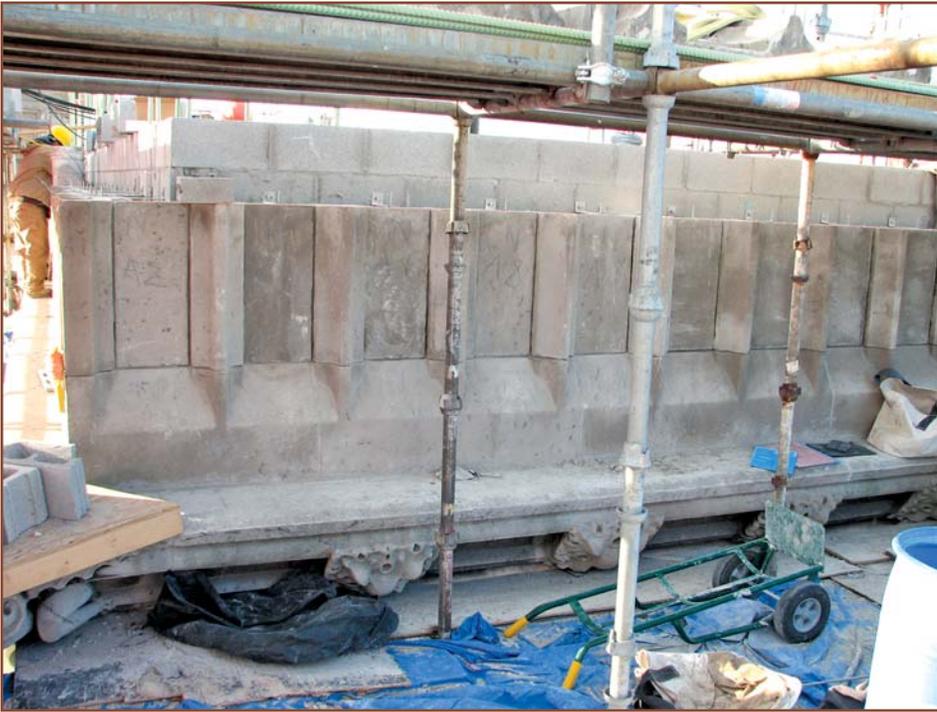
Photo 7 – Reinstallation of cut/carved limestone cladding with stainless steel anchors.

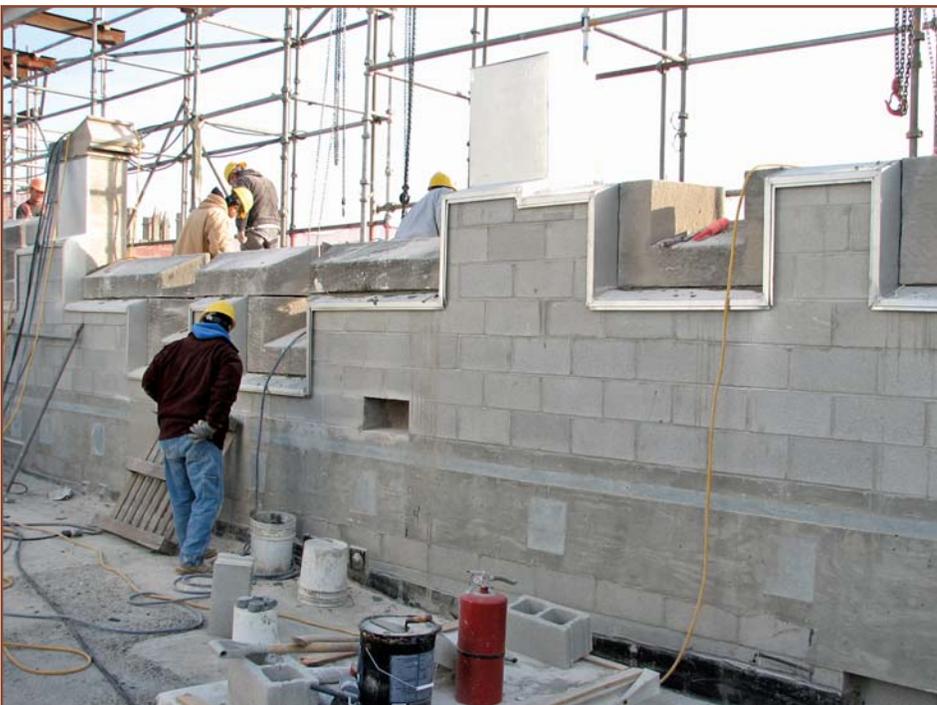
Photo 8 – Fully integrated zinc- and tin-coated copper receiver flashings below stone copings.

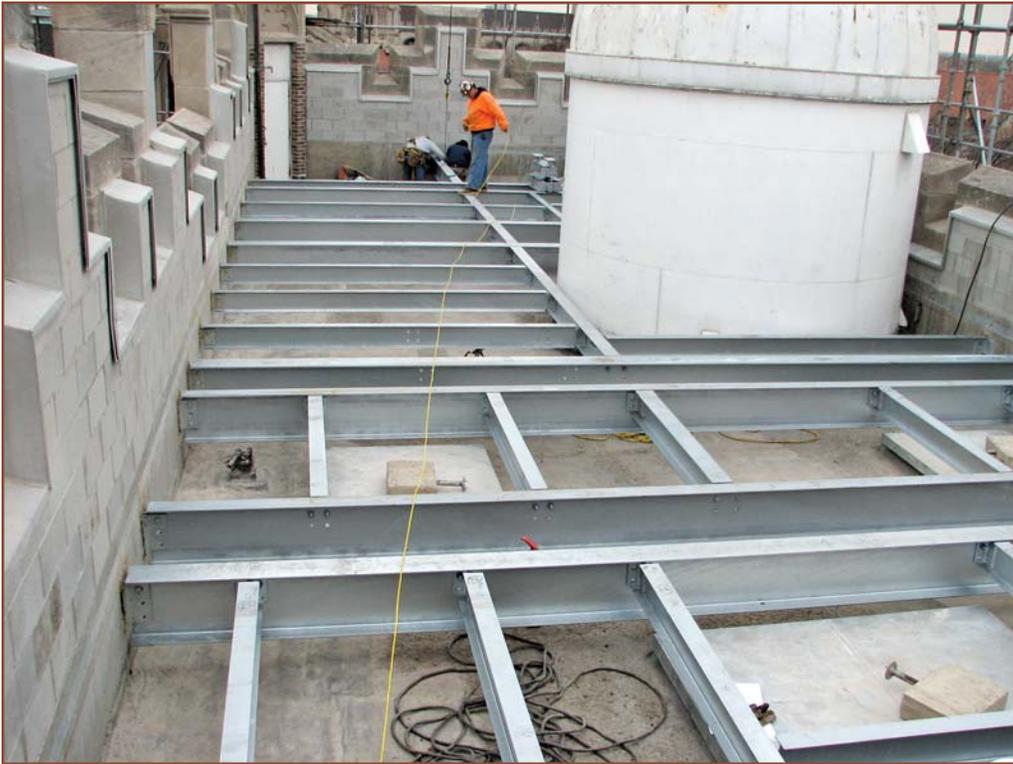
Photo 9 – The introduction of new, galvanized structural framing elements above the original roofline.

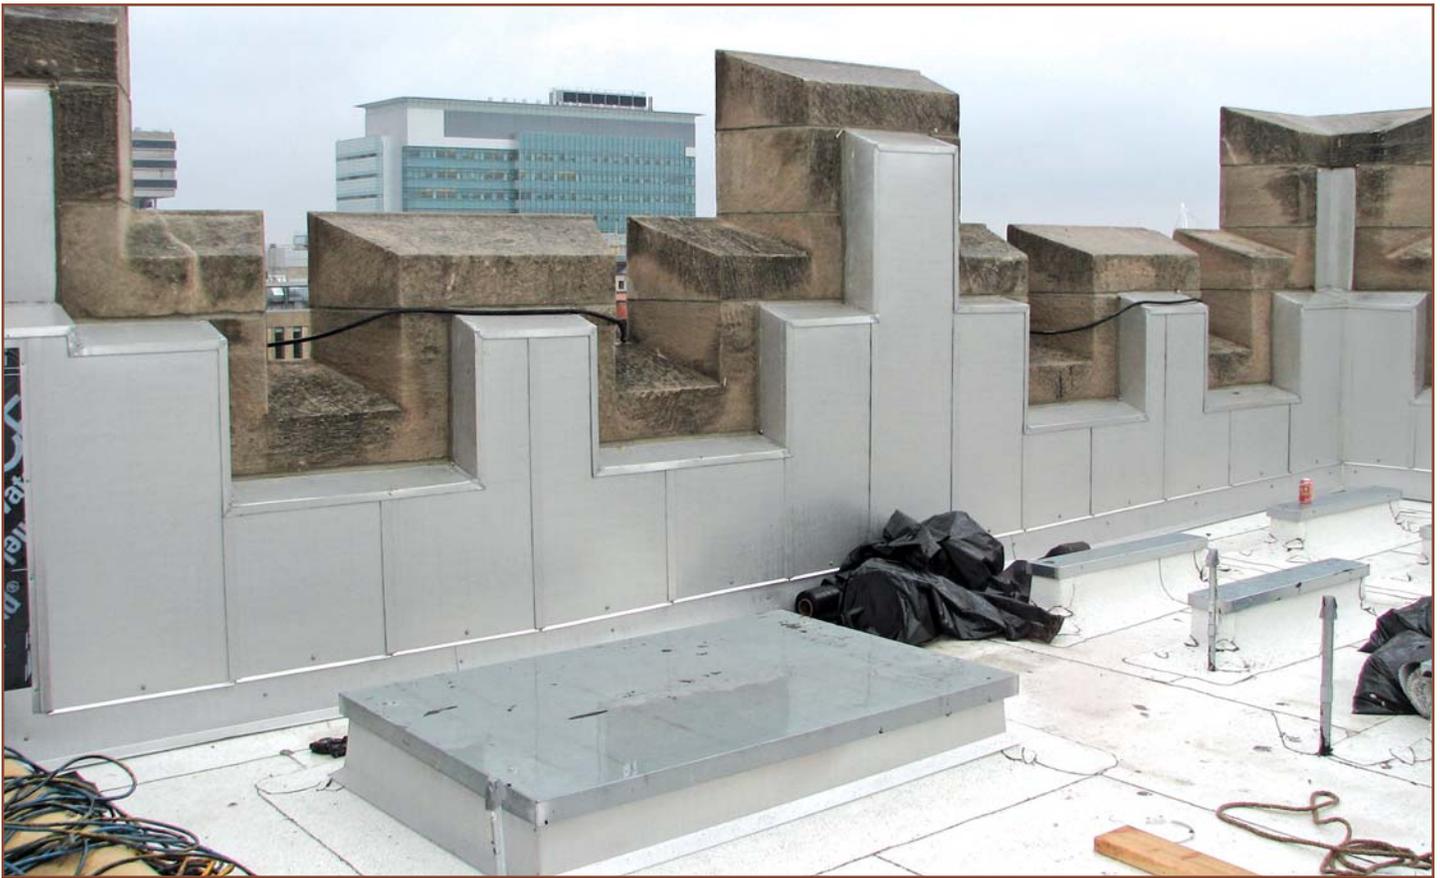
Photo 10 – Fully completed parapet and new roof assembly.
