Low-Slope Roofs Are Rotting: Case Study Resolution

By Dwight D. Benoy, PE;
Pamela Jergenson, CCS, CCCA, BECxP, CxA+BE;
and Gary C. Patrick, RRC, AIA

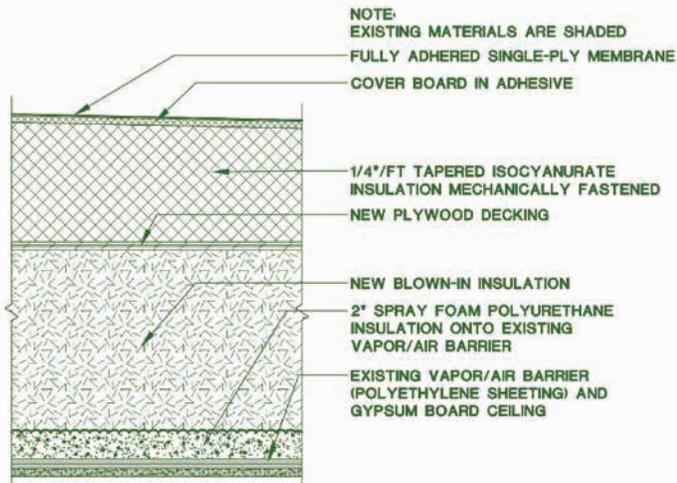
Figure 1

This option (Figure 1) was intended to create a complete vapor/air barrier by installing spray foam over the existing polyethylene sheeting and bottom chord of the truss. This required the removal of the existing roof system down to the structural roof deck and removal of a significant portion of the roof deck to facilitate vacuuming the existing blown-in insulation out of the truss space, and installation of the spray foam insulation and new blown-in insulation. New tapered insulation and roof membrane above the structural roof deck were part of this solution.

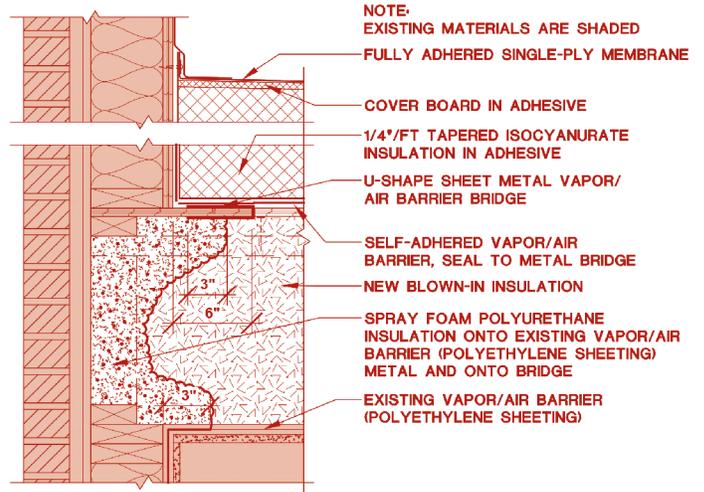
Figure 2

Option 2 (Figure 2) required removal of the existing roof system down to the structural roof deck, and replacement of any wet, rotted, and/or moldy deck and blown-in insulation. A roof vapor/air barrier would be applied on the structural roof deck.

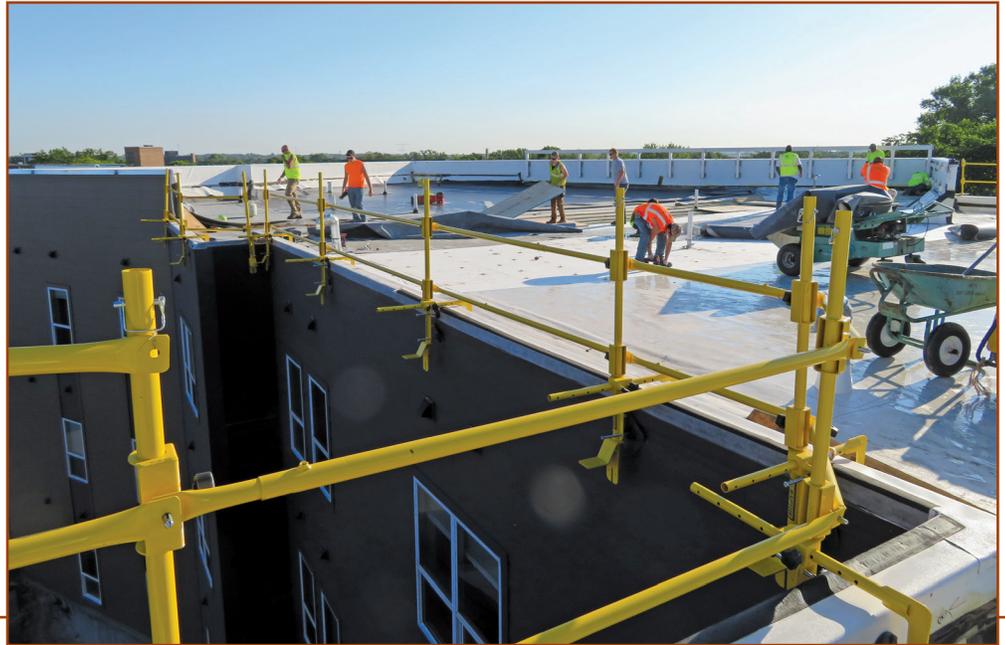
Figure 15
– Perimeter
safety rails.

Perimeter safety was primarily accomplished with rails attached to the parapet (Figure 15). A safety monitor was also assigned to work with the crew applying the low-rise foam adhesive for the insulation attachment.

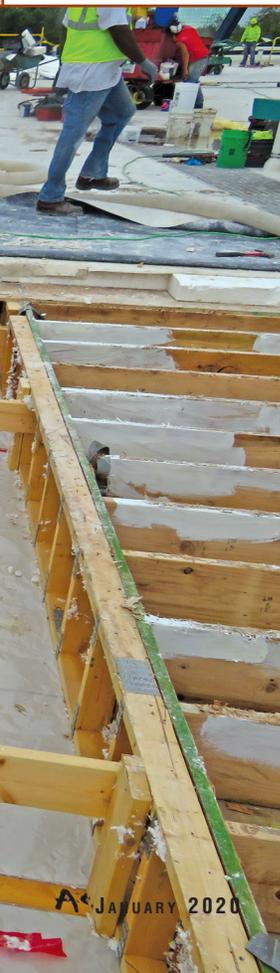
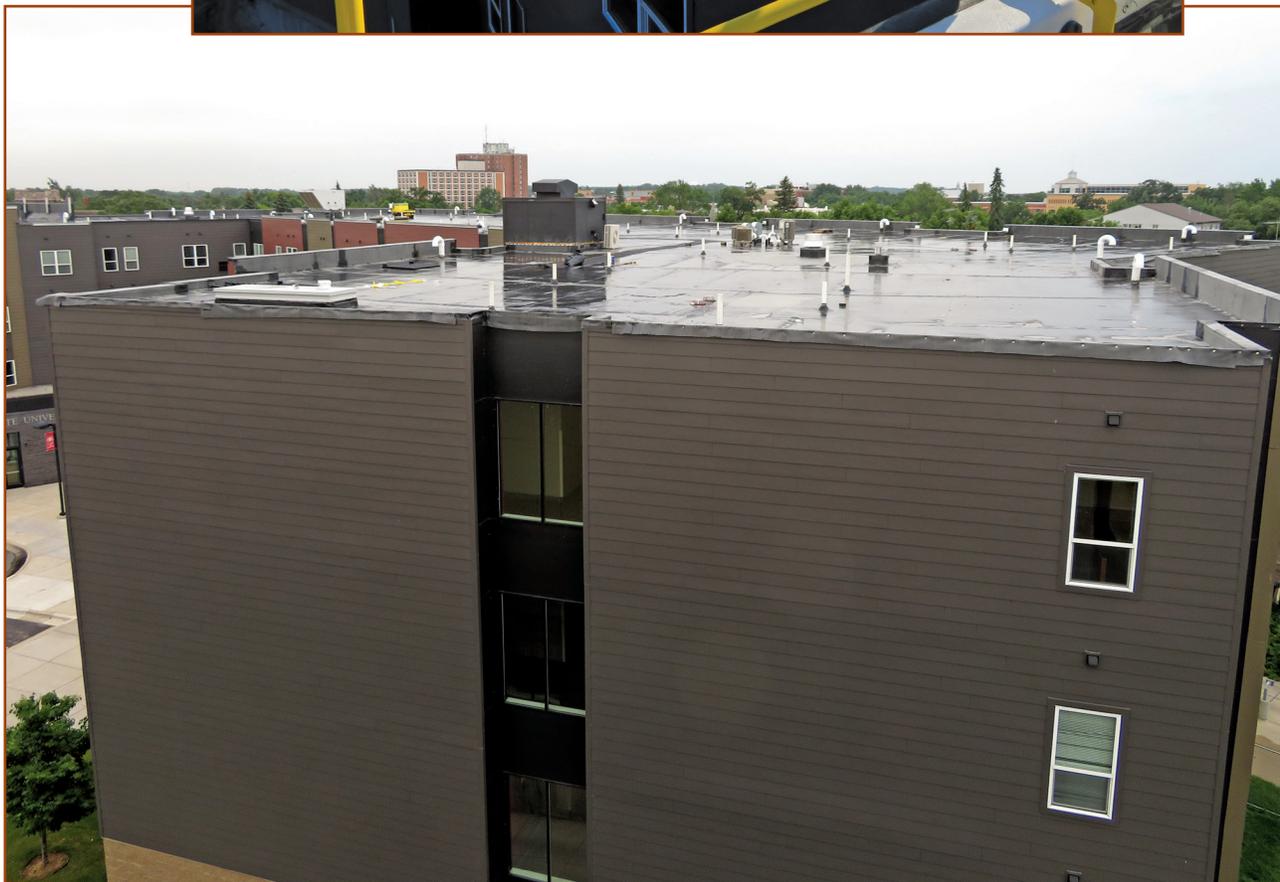
Figure 16 – Completed roof.

over the tapered insulation system provided a fully draining roof with a finished appearance (Figure 16). Even with all of the construction challenges, the roof was completed in a timely manner.
