Improper Use of Storefront Window Systems Leading to Costly Repairs:

A CASE STUDY

By Jason Popovich

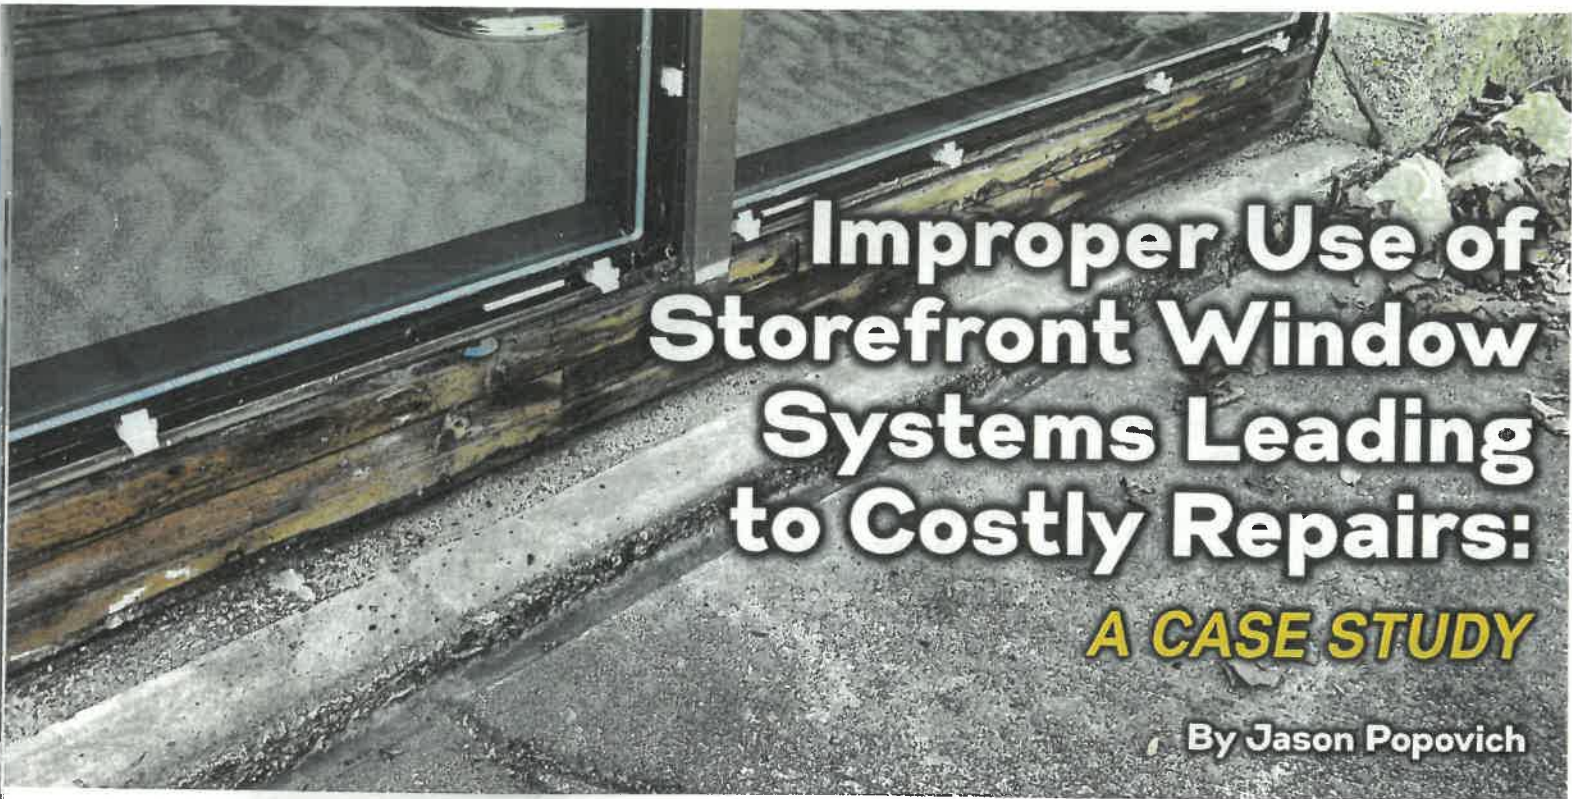
In early 2021, members of a church in Minneapolis, Minnesota, were frustrated after experiencing years of issues dealing with water infiltration below the church windows, which had caused the plastic-laminate sills to visibly swell as they took on water (Fig. 1).

Figure 1. Visible moisture damage of the plastic laminate sills. Photo courtesy of Inspec.
