Beyond 20-Year Low-Slope Roof Performance

Gary C. Patrick, AIA, CSI

Abstract

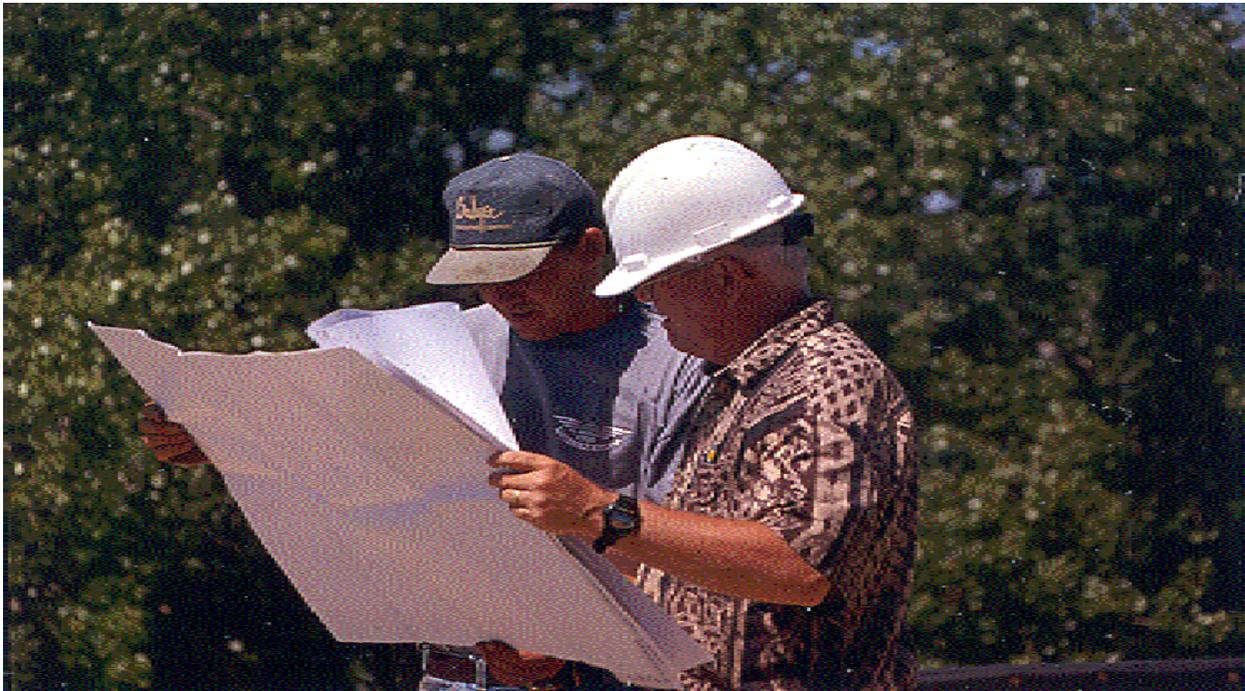
Reviewing construction documents during an inspection.

- Testing of materials and review of submittals prior to construction.
- Reviewing construction documents with the roofing foreman.
- Pre-construction conference.
- Periodic inspection during construction.
- Moisture and temperature testing of materials during construction.
- On-site testing of the four-ply membrane construction quality using a 4-by 36-inch (102- by 914-mm) test cut with immediate results. Lab testing follow-up.
- Fastener withdrawal testing as required.
- Written daily inspection reports to all parties.
- Warranty and other contract closeout work.

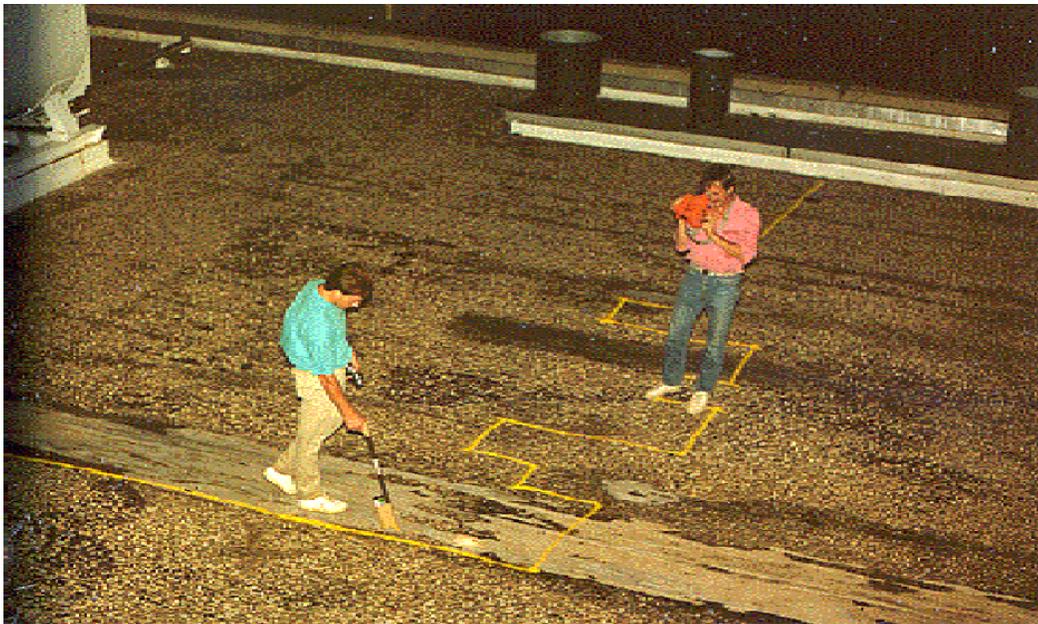
Infrared Evaluation

- Annual roof system walkovers by a trained person.
- Infrared evaluation (on applicable system) every two years.
- Survey walkover with roofing contractor and owner prior to five-year contractor warranty expiration.
- Roof management report every two to five years with repair/replacement recommendations, including all costs and time frames.

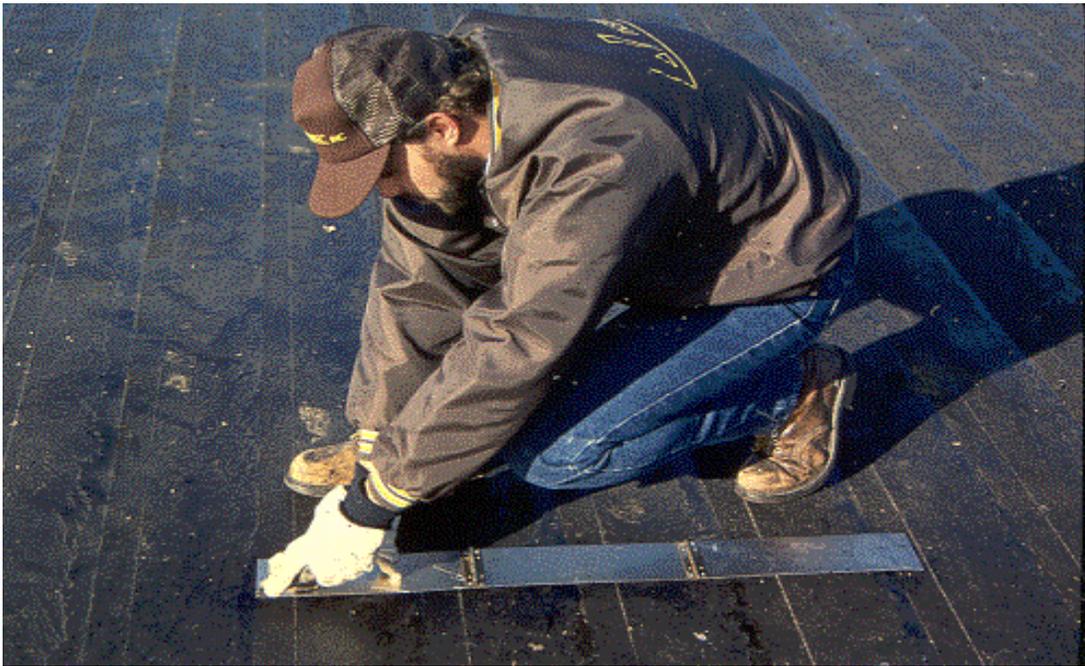
Roof Membrane Test Cut

- Coordination of sub-consultant's inspections.
- No surprises for the owner.
- Membrane test cuts for analysis of material weights, lapping and lamination.

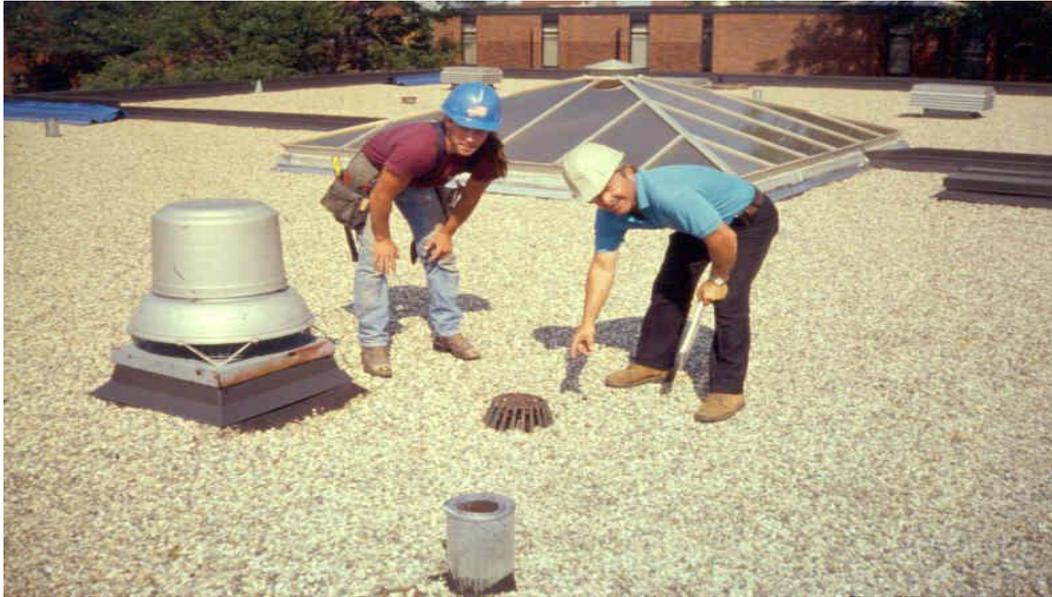
Annual Roof Survey

- The facility shall maintain historical records for each roof system.
- The facility should visually inspect roofs immediately following severe weather, documenting any signs of damage and schedule repairs as soon as possible.
- Annual roof survey conducted by a MnSCU designated Roofing Consultant. These will include infrared roof moisture surveys and a comprehensive report. Schedule repairs as soon as possible.
- Verify that roof access is minimized and that roof drainage is unobstructed.
- Check and secure any loose metal flashing.
